ANNUAL REPORT 2017

Land Transport Accidents Investigation Board (BEA-TT)
Grande Arche – Paroi Sud
92055 La Défense cedex
Tel : 33 (0)1 40 81 21 83 – Fax : 33 (0)1 40 81 21 50
email: Bea-tt@developpement-durable.gouv.fr
web : <http://www.bea-tt.developpement-durable.gouv.fr>

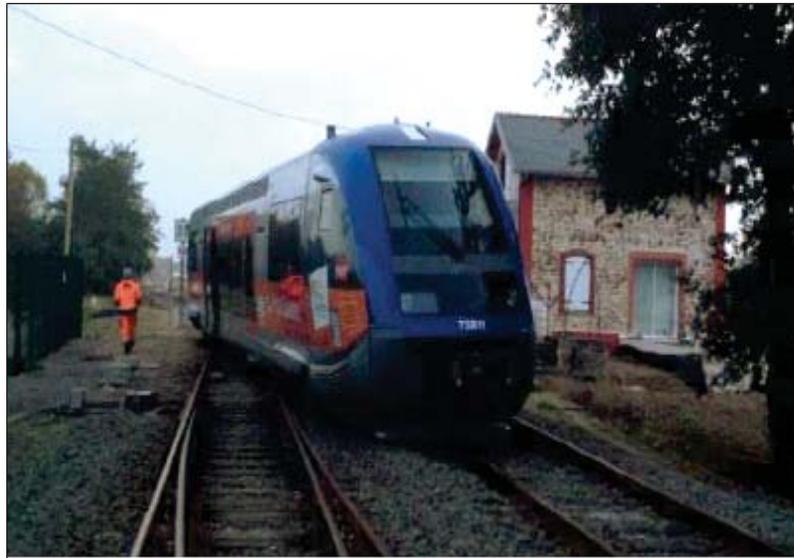
Dual-track derailment of TER no. 859100 at the Sainte-Pazanne (44) station on 12 October 2015

On 12 October 2015 at 05:40, railcar X 73811 coming from Saint-Gilles-Croix-de-Vie and pulling regional express train no. 859100 derailed across both tracks, at low speed, on switch points 310b located at the entrance of the Sainte-Pazanne station. It stopped 30 metres down with its front bogie on track 2 and the derailed rear bogie on track 1.

The material damage was limited to the running gear of the railcar, the rear bogie of which rolled about thirty metres in the ballast, with trail through of points by the leading bogie, with about thirty metres of track covered by the derailed bogie.

On the one hand, this event was caused by a 2.7 second disruption on the ITE track circuit in zone 325 and, on the other hand, the Sainte-Pazanne traffic control agent's recording of an incompatible route with that of the train in question; this recording was authorised by instruction S6A no. 4 from Infra-Exploitation Pays de Loire.

- taking into account the phenomenon of wheels getting clogged;
- cleaning the rails after track repair operations;
- the procedures for issuing S6A no. 4 exemptions;
- the implementation of modern points.

In addition, the investigation showed that the disruption of the CDV ITE track circuits deserved specific monitoring and attention, which led the BEA-TT to formulate a fifth recommendation on this topic.

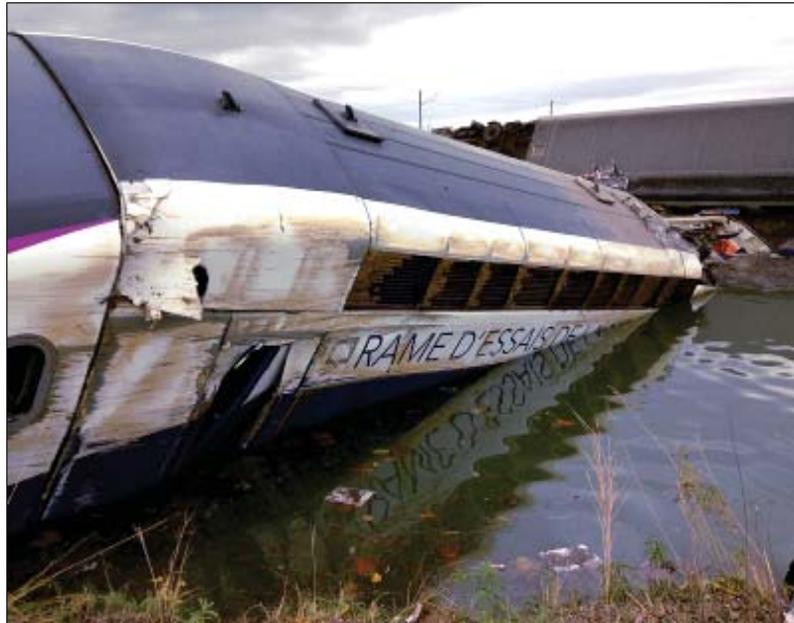
**Derailment of a TGV train
during a test run of the East-European LGV
on 14 November 14 2015
in Eckwersheim (67)**

On Saturday 14 November 2015 at 15:04, during an overspeed test carried out as part of the approval procedure for the second part of the East-European Line, the test train traveling on track 2 towards Strasbourg derailed shortly before the bridge over the Marne-Rhine Canal, at the entrance to the easement curve of the new line with the Paris-Strasbourg classic line in the Eckwersheim commune.

The train broke up; the front engine and the six carriages that followed it scattered across the ground situated below the track and stopped after having crossed the canal using this momentum; the tail engine fell into the canal and the two cars ahead ended up on the bank.

The TGV train was completely destroyed and the railway bridge was seriously damaged.

The direct cause of the accident was the tilting of the power unit and the train from the effects of the centrifugal force resulting from an approach speed of 255 km/h in a tight bend with a 945-m radius.

This excess speed was due to the inappropriate braking considering the initial speed of the train when approaching the area that begins just before the bend in question where the recommended maximum speed is only 176 km/h.

The report also makes a specific recommendation to implement "loopbacks" when security systems are to be deactivated.

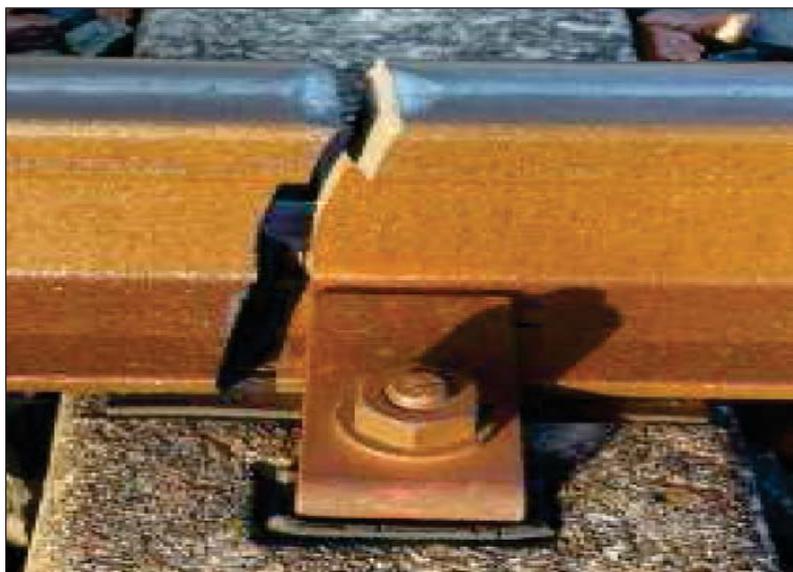
**Multiple rail breaks
when train no. 72049 passed through
between Pons and Jonzac (17)
on 13 December 2016**

On 13 December 2016, at approximately 08:30, the 447 and 462 level crossings at Pons and Jonzac, respectively, on the Saintes - Bordeaux line section were reported as "failing to open".

The Electrical Service Officer (SES) was called to rectify the LC 447 and detected a broken rail at 09:45. Investigations on LC 462 led to the discovery of a second broken rail at 10:45 and a third at 11:40.

Over the following days, walking inspections, train inspections and auscultations were conducted along the entire train route. In total, 13 rail breaks were noted on the train's route. Twelve were in an area 50 km from the Saintes - Bordeaux line. An isolated case is located on the single track from Niort to Saintes.

These breaks were caused by violent impacts caused by the movement of a wagon in train no. 72049, on which two wheels of an axle each had a flat spot of about 110 mm.

Despite the noise and vibrations produced by the bearing of this defective axle, the train was not stopped by the running trains surveillance posts (STEM) located on its route.

- the self-contained empty-loaded systems fitted to certain wagons;
- the motivation of agents performing STEM in terms of detecting the flat spots on the wheels;
- the deployment of wheel defect detectors on the national rail network (RFN).

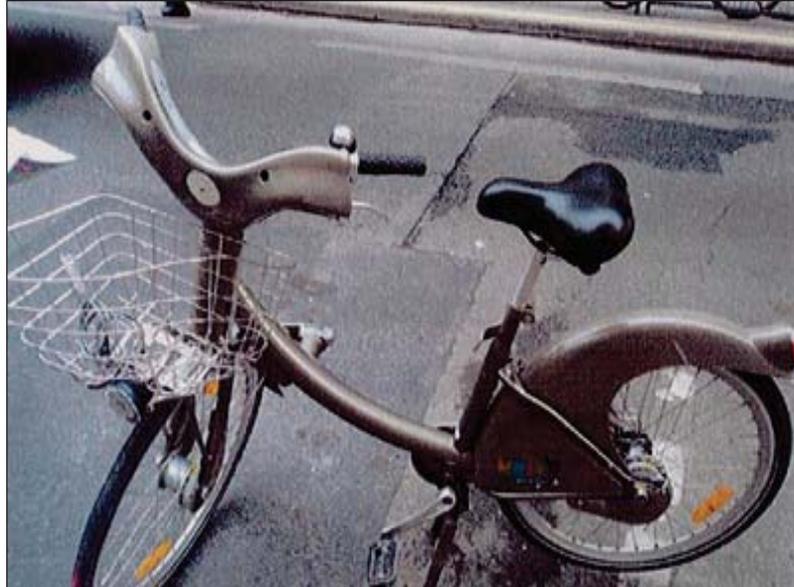
Accident between a cyclist and a truck that took place on 17 August 2015 in Paris 9th at the crossroads between the rue de Bruxelles and rue de Douai

On 17 August 2015 at 08:42, a truck was stopped at rue de Douai (9th district of Paris) at a red traffic light at the crossroads between rue de Douai and rue de Bruxelles. It started up again when the lights turned green and turned right to take the rue de Bruxelles, hit a cyclist on its right front side.

The cyclist, who was cycling in the same direction as the truck and continued straight ahead, fell to the ground on the impact and found himself under the wheels of the truck, which stopped in the middle of the crossroads.

The main cause of this accident was that the cyclist had not been visible to the driver of the truck.

For example, an active driver assistance system such as the Blind Spot Information System, which was submitted by Germany in 2017 as a draft UNECE regulation, could fulfil the driver information function for blind spots.

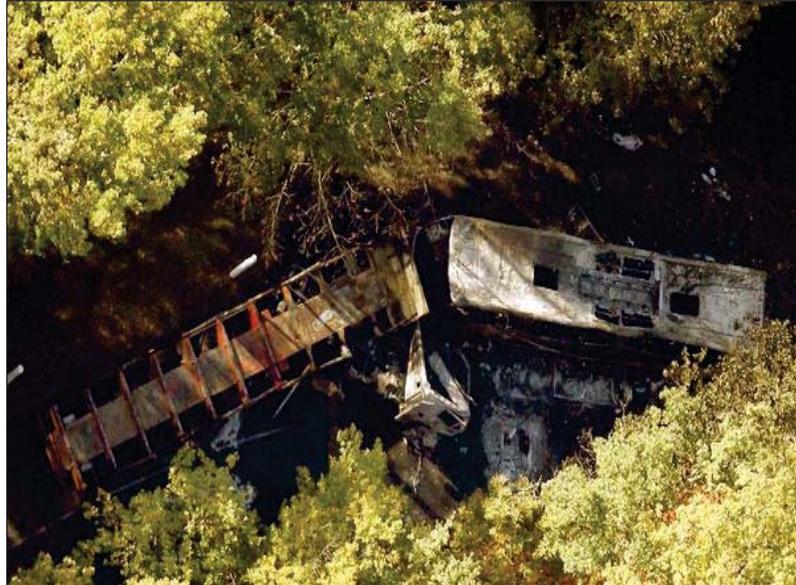
**Collision (and resulting fire)
between a coach and an HGV that occurred
on 23 October 2015 on
RD 17 road near Puisseguin (33)**

On 23 October 2015, at around 07.30, near the town of Puisseguin in the department of Gironde (33), an articulated lorry (consisting of a tractor unit and an empty wood trailer) with two people on board, travelling on the B-Road RD 17 towards the town of Puisseguin, jack-knifed when navigating a right-hand bend and passed into the opposite lane, colliding with a coach carrying 49 people which was travelling in the opposite direction.

A fire broke out immediately after the crash and engulfed both vehicles.

The accident resulted in the deaths of 43 people (41 coach passengers and the two people travelling in the HGV), and caused injuries to 8 others who were able to escape from the coach (the driver and 7 passengers).

The direct cause of the accident was the loss of control of the HGV as it was navigating a tight right bend, causing the vehicle to swerve into the left hand-lane and collide with a coach travelling in the opposite direction.

- improvements to the opening mechanisms for smoke extraction devices, in order to make them easier to use;
- the addition of emergency doors at the rear end of such vehicles, or failing this, extending the provisions of Decree no. 2015-1170, issued on 22 September 2015 (pertaining to accessibility in vehicles designated for use in providing inter-urban public transport services) to all buses and coaches, and/or improving industry standards regarding the opening mechanisms of emergency exit windows in order to make them instantly manoeuvrable and easier to use in the event of an emergency evacuation of the vehicle;

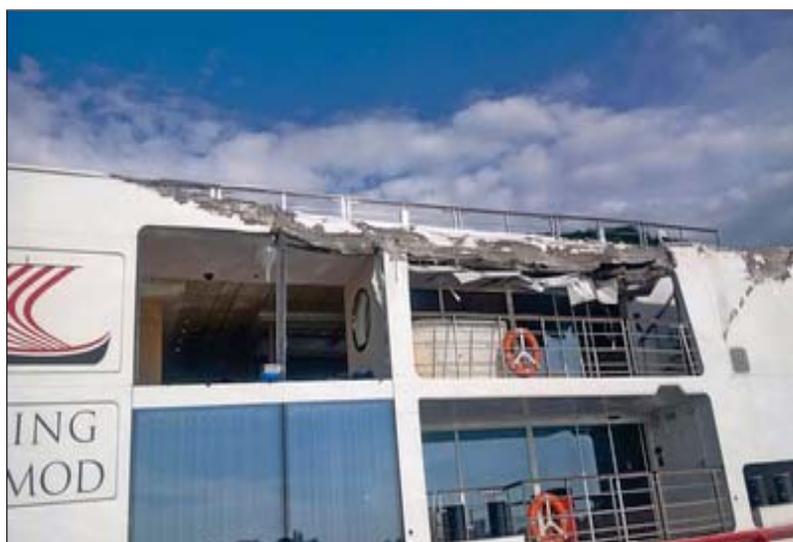
Collision of the VIKING HERMOD passenger boat with the La Voulte-sur-Rhône SNCF bridge on 6 June 2015

The VIKING HERMOD passenger boat cruises the Rhône between Mâcon and Avignon. Starting in Lyon, it sailed down the river on 6 June 2015 when it was caught in a violent storm along with heavy rain greatly reducing visibility.

It sailed up to the La Voulte-sur-Rhône bridge, located at PK 128.6, to cross the downstream boats pass. It was in these conditions that it was pushed onto the bridge pier, which is to the left of its path, by the strong wind of the storm, without being able to control its position, neither by sight, nor by radar. When the captain was finally able to see the bridge coming up, the boat could no longer avoid the collision and, at around 22.30, hit the bridge pier with the superstructures located port side.

The investigations carried out make it possible to establish that the direct cause of the accident is the poor approach of the Voulte-sur-Rhône SNCF bridge by the VIKING HERMOD passenger boat, which came in too much to the left of the downstream boat pass. This situation is directly linked to the storm that was raging at the time of the manoeuvre. The heavy rains completely eliminated visibility and saturated the radar image with echoes. Therefore, there was no way to detect markers marking the bridge piers. At the same time, the strong wind pushed the boat against the deck pile to the left of the passing boats.

When the captain saw the bridge pier at the last moment on the front of the boat, they could not completely avoid it, especially since the manoeuvring capacity of the boat was reduced by the damage to two of the four rear thrusters.

- the lack of radar detection of the beacons positioned upstream of the bridge piers;
- the manoeuvrability of the VIKING HERMOD, which was restricted by the failure of two of the four rear azimuth thrusters to propel and manoeuvre the boat;
- the captain's workload, whose vigilance and his decision-making abilities had been depleted due to fatigue, which is itself related to the high number of working hours resulting from the grounding of the VIKING HERMOD passenger boat in Mâcon and subsequent repairs.

In light of these considerations, the BEA-TT makes a recommendation to the Viking River Cruises Company regarding the need to report to the authorities, in accordance with police rules, any damage that may hinder the manoeuvrability of the boats or the safety of navigation.

Beyond this formal recommendation, the BEA-TT draws the attention of Viking River Cruises to the need to encourage crews to respect maximum working hour limits provided by the regulations and invites the waterway manager to study the installation of radar reflectors.

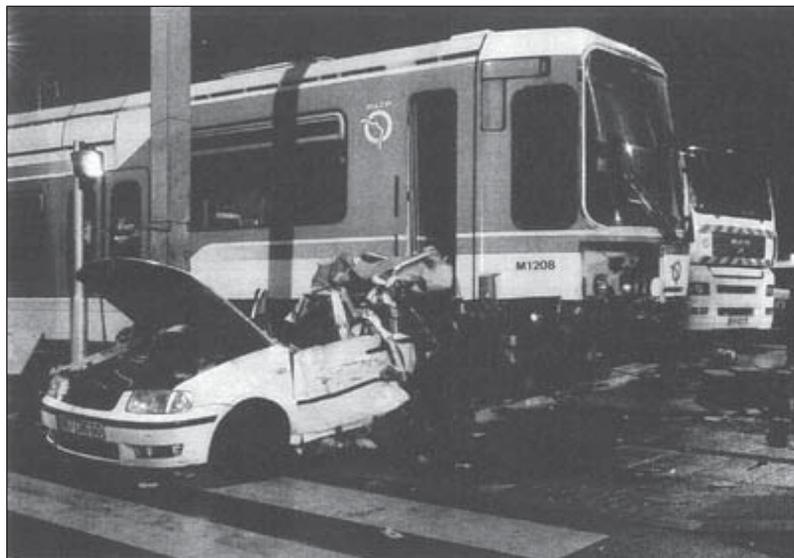
Collision between a tramway and a car on 21 December 2013 in Saint-Denis (93)

On Saturday 21 December 2013, at 19:50, a car traveling on the road from La Courneuve to Saint-Denis (93) crossed a traffic light at the intersection with rue Voltaire, turned left and went onto the platform of the Ile-de-France tramway T1 line.

A train going in the same direction and whose signal light also authorised it to cross the intersection, hit it and pushed it against a pole supporting an overhead contact line.

The direct cause of the accident was the car's entry onto the tramway platform when a tram was approaching. Two factors contributed to the collision:

- the layout and signage of the intersection of the route de la Courneuve with rue Voltaire;
- the prevention of the risks of the outcome of collisions being worsened by fixed obstacles;
- feedback from tram accidents, and the participation of road managers in it.

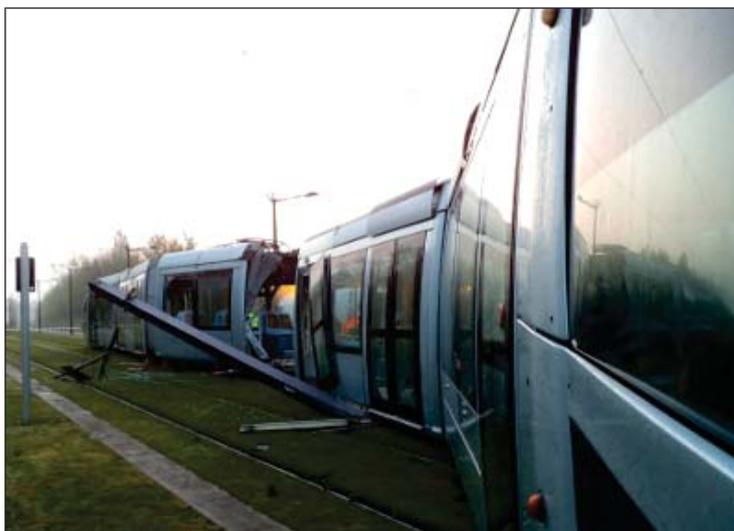
Derailment and dislocation of a T1 tramway train on the Valenciennes (59) line on 11 April 2014

On Friday 11 April 2014 at 04:40, the 417 train left the Saint-Waast storage depot and entered the T1 tram line of the Valenciennes network. Only the first two bogies passed the switch to engage on track 1 properly. The third bogie continued its course on track 2 following a double track.

The train accelerated to 24km/h and continued sideways for 70 metres. It then collided with an overhead contact line support pillar located between the tracks. The train broke in two due to the impact and came to a stop.

The accident caused no injuries, only the driver was present. The accident caused extensive damage to the rolling stock and infrastructure.

The direct and immediate cause of this accident was the change of position of a switchgear between the passage of the second and the third bogie of the train when leaving the depot.

These causes stem from the incorrect use of signalling automation by the operators, itself caused by a lack of precise instructions detailing the operating procedures to be implemented, and by the management's lack of rigour in observing and dealing with security faults at the centralised control station.

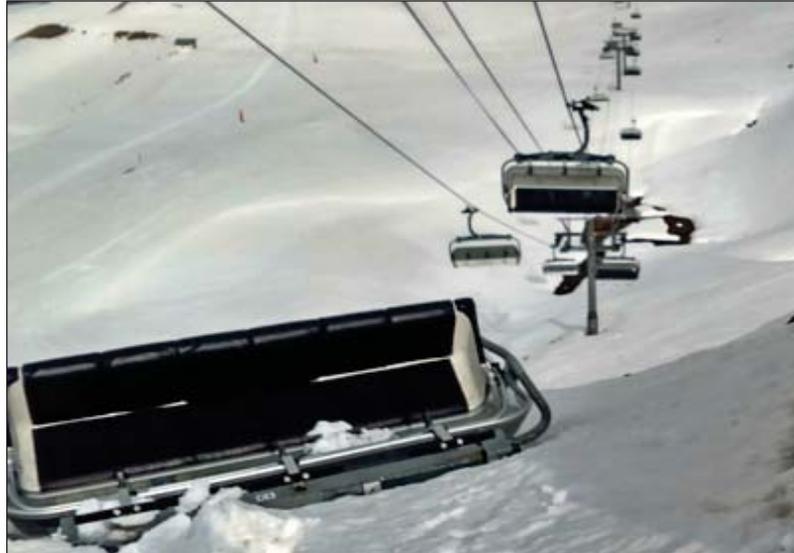
Fall of an empty chair from the Granges chairlift on 4 April 2016 in Menuires (73)

The event relates to the *Granges* chairlift located on the skiable part of Menuires.

At 12:21 on 4 April 2016, in overcast and windy conditions in which the anemometers of the *Granges* chairlift triggered several “strong wind” alerts during the morning, an empty chair swinging in a gust of wind caught the walkway on pylon P10 and fell to the ground.

- the rules relating to the use of the installation when it is very windy;
- the information on the strength and direction of the wind provided to the driver;
- maintenance of the bubble locking system;
- the risk linked to the seats wobbling due to the wind being acknowledged in the gauge rules and standards.

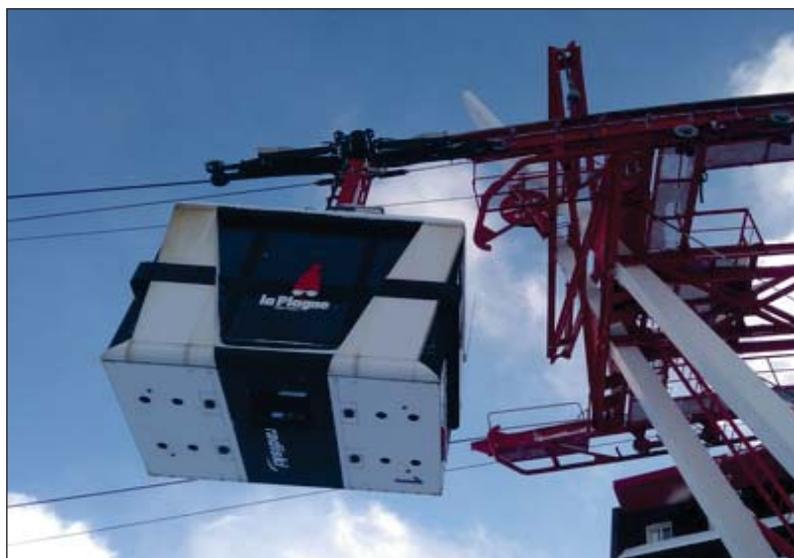
Telemétre derailment which occurred on 12 January 2017 in La Plagne (73)

The accident concerns the "Télémetro" cable car which connects the two resort villages of Plagne Centre and Aime 2000 on the skiable area of la Plagne.

On Thursday 12 January 2017 at 21:04, it was snowing heavily. While the cabin descending from the cable car went to the right of the pylon P2, the carrier cable escaped from its support at the head of the pylon. It became stuck in the traction cable's support wheels, located underneath. The cab derailed and stayed balanced on the cable. The installation stopped automatically by triggering an overlapping safety alarm for the traction and carrier cables.
