Bureau d'Enquêtes sur les Accidents
de Transport Terrestre

ANNUAL REPORT 2018

Land Transport Accidents Investigation Board (BEA-TT)
Grande Arche – Paroi Sud
92055 La Défense cedex
Tel : 33 (0)1 40 81 21 83 – Fax : 33 (0)1 40 81 21 50
email: Bea-tt@developpement-durable.gouv.fr
web : <http://www.bea-tt.developpement-durable.gouv.fr>

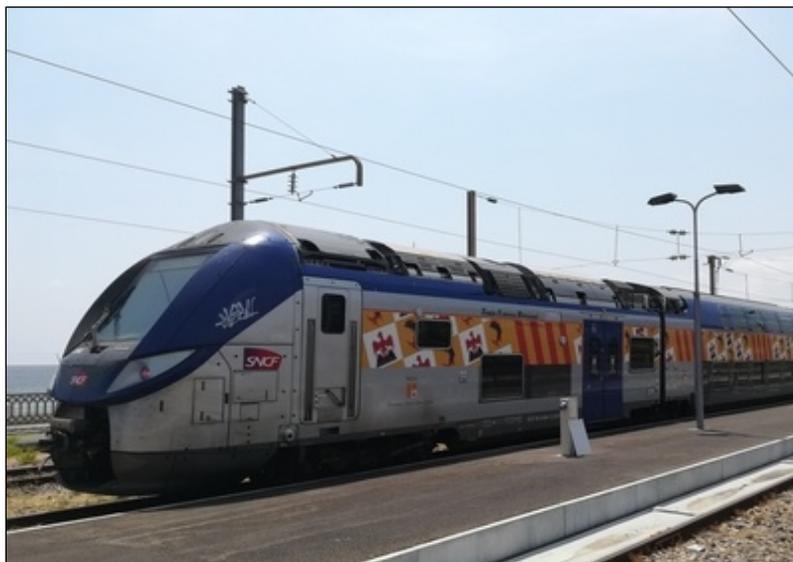
TER crossing a closed signal and running through a switch at Antibes (06) on 26 December 2016

At 16:10 on Monday, 26 December 2016, in the Antibes station, TER No. 86036 Ventimiglia Cannes ran through, at a speed of 15 km/h, a track switch located on the main AN2 track and positioned to allow the crossing of a TGV arriving on the central rail.

The impact was the consequence of crossing the C1324 signal, which was closed and was not observed by the conductor.

There were no victims or damage to rolling stock material. Only the impacted switch was damaged, rendering crossing impossible and thus, circulation on the AN2 track.

- the speed control automated system (KVB) which was out of service following a software failure on the train;
- the signal detonator, whose cartridge had exploded and was not perceived by the conductor;
- the "closed signal" repetition in the cabin that should have led the conductor to initiate emergency braking.

- the processing of computer bugs disturbing the functioning of KVB on the SN Regio material;
- the ability of new traffic agents to handle complex situations.

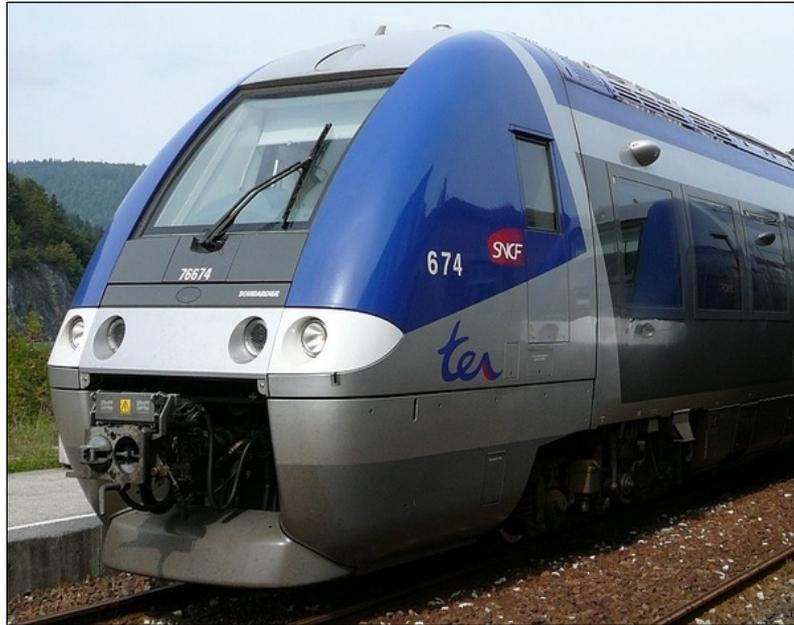
Two TERs catching up to one another on 18 August 2017 near the La Redonne-Ensuères station (13)

At 08:40, on Friday, 18 August 2017, the conductor of the TER 879719 Miramas – Marseille-Saint-Charles via Martigues, while leaving the Metheron tunnel, noticed the two rear red lights of the TER 879715, which was traveling on the same track in front of him.

The conductor of the TER 879719 initiated emergency braking and stopped near kilometer 857,400, around 50 m from the TER 879715. A collision was avoided.

The cause of this incident is a lack of respect by the signalman in the Martigues station of the procedure that includes, in a situation involving a disruption in the block, to ensure that the block is free of any traffic before authorising a train conductor to use axle counter reset preparation system and to cross a signal presenting the indication “semaphore.”

The failure to respect the procedure led these two trains to be in the same block when the system only counts one. The first train leaving the block put the signal “open lane” (green light), allowing the entrance of a new train at full speed in the already occupied block.

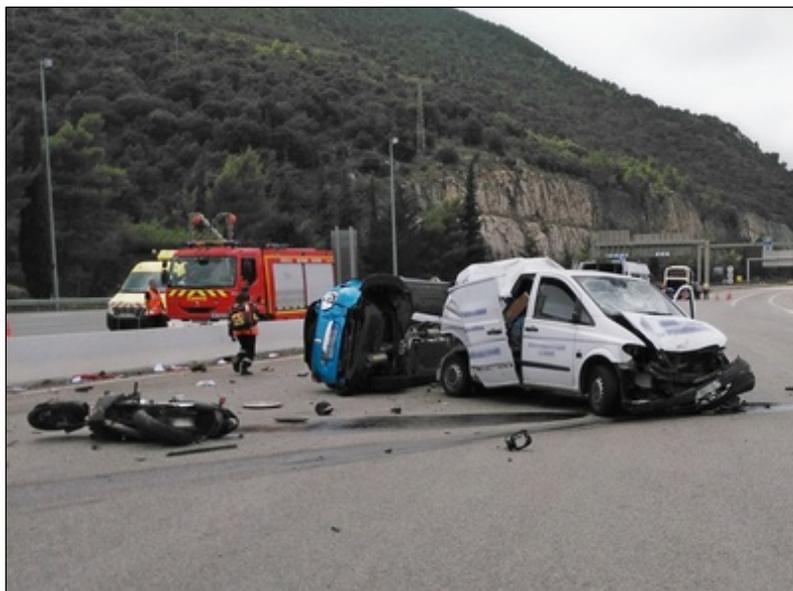
Pile-up involving a bus, two light vehicles and a motorcycle on 17 September 2015 on the A8 highway to the right of the La Turbie (06) toll gate

At 13:30, on Thursday, 17 September 2015, an accident involving a bus, two light vehicles and a motorcycle took place on the A8 highway in the direction of Italy to France at La Turbie toll gate in the commune of La Turbie in the Alpes Maritimes (06).

In this accident one passenger in the bus died and 20 people were injured among the passengers in the bus and the light vehicles as well as the motorcycle driver.

The direct cause of this accident is the loss of control of a bus by its driver, following an inappropriate speed as it approached the toll gate.

Consequentially, BEA-TT formulated, for the Estérel Côte-d'Azur highway company, a recommendation with regard to the reinforcement of signaling in order to inform heavy vehicle drivers of the dangerous nature of the descent and the importance of controlling their speed.

BEA-TT also recommends to the Alpes-Maritimes Prefecture and Delegation of Road Safety the installation of a speed camera for the La Turbie slope.

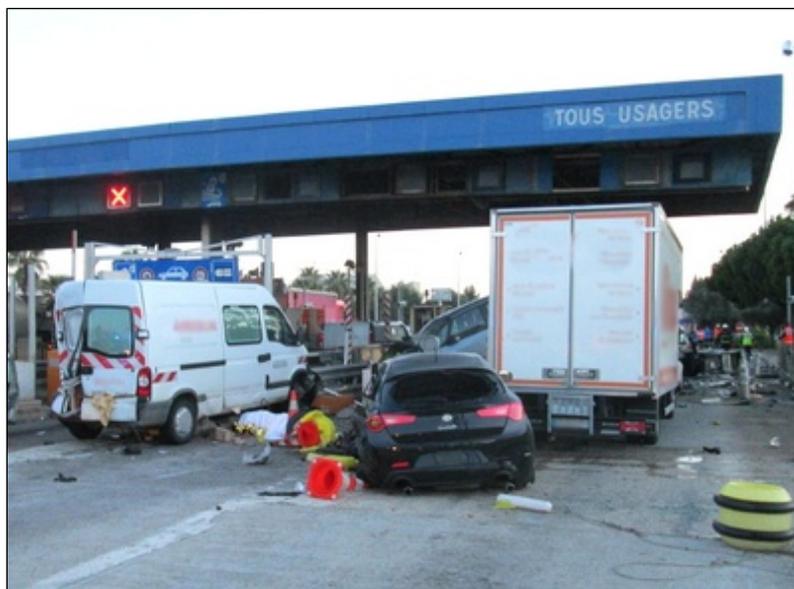
Accident that occurred on 29 October 2015 in Nice (06) on the A8 highway at the Saint-Isidore toll barrier

Around 16:50, on Thursday, 29 October 2015, a car-carrying articulated truck traveling on the A8 highway in the direction Italy – Aix-en-Provence, driving on the last part of the Nice Saint-Isidore descent, suddenly lost its braking ability a few hundred meters from the toll.

The articulated truck descended this steep slope zigzagging between the vehicles and arrived at the toll at a speed of around 115 km/h.

This accident took the life of a motorcyclist, caused injuries to eight people, several of them had to be hospitalised for more than 24 hours, and led to significant material damage.

The direct and immediate cause of this accident is the failure of the braking system of the articulated truck in the descent.

- the degraded state of the braking system;
- the accessibility of arrester beds.

The analysis of this accident led BEA-TT to formulate two recommendations for the ESCOTA company, and one for the Directorate General for Infrastructure, Transport and the Sea (DGITM), regarding the safe distance between heavy vehicles and the signaling of arrester beds.

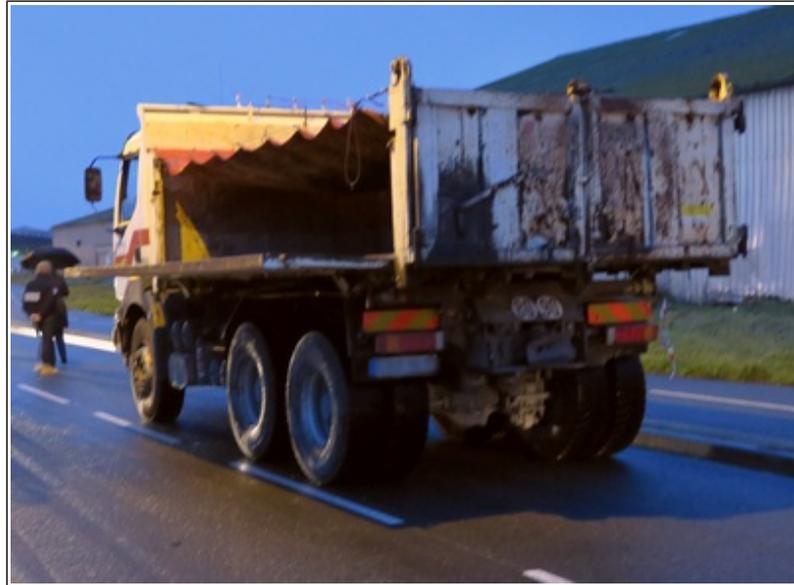
Collision of a school bus and a heavy vehicle which occurred on 11 February 2016 in Rochefort (17)

On the morning of Thursday, 11 February 2016, on avenue Victor-Louis Bachelar in Rochefort (17), around 07:10, a school bus passed a dump truck whose left sideboard was open at a 90° angle with regard to the vertical.

Encroaching on the opposite lane at the time of crossing, the sideboard sliced the entire left side of the bus, killing six young high school students seating next to the window.

The direct cause of the accident is the overage, width-wise, of the size of the truck.

- the conditions of the moment, darkness of the night, mist, and the shadowed area of the left side of the truck could have hindered the driver;
- the absence of a warning device to alert the driver that the sideboard was in an open position before proceeding and traveling on the public road;
- the absence of signaling of this sideboard, which was not seen by the driver of the bus until the moment of passing.

- the improvement and securing of warning devices;
- the enhancement of prevention using the unique risk assessment document.

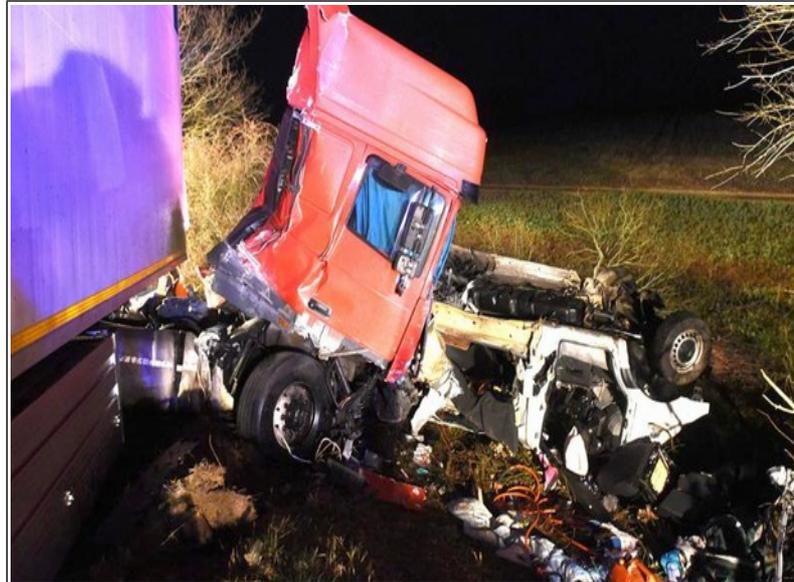
**Collision involving
a heavy vehicle and a van
which occurred on 24 March 2016
on the RN 79 at Montbeugny (03)**

At about 23:40 on Thursday, 24 March 2016, a van with a trailer carrying 12 people travelling from Switzerland to Portugal for Easter collided with an articulated truck on National Road No. 79 in the commune of Montbeugny (03).

This accident cost the lives of 12 people, all passengers in the van.

The direct cause of the accident is the decision of the van driver who, without sufficient visibility, attempted to overtake, at an excessive speed, with a vehicle in a deplorable state (worn brakes and tires) and with overload, which was also pulling a trailer in poor technical condition.

The consequences of this action were a head-on collision with an articulated truck and the death of 12 people present in the van and transported in an illegal and dangerous manner (seats illegally added with defective or missing seatbelts...).

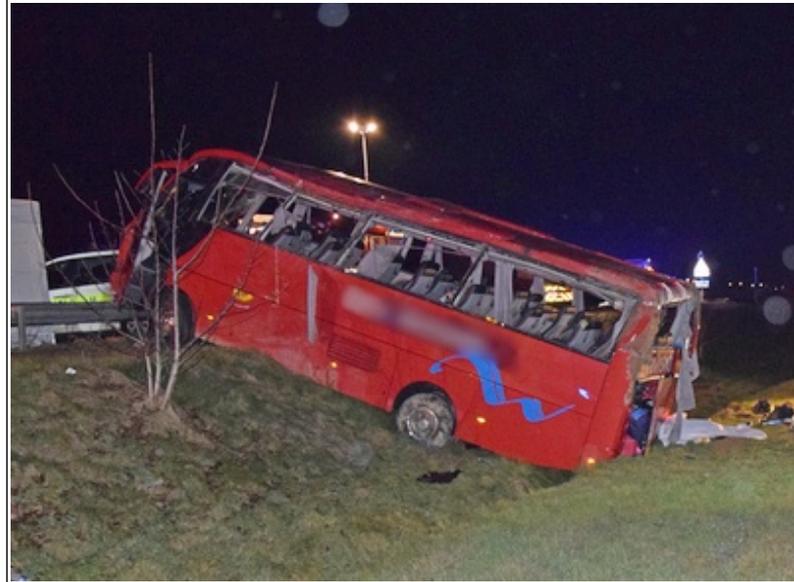
**Bus run off the road
on the RN 79
on 8 January 2017
in Charolles (71)**

On the night of 7 to 8 January 2017, at about 04:12, a bus pulling a trailer, which was transporting 32 people from Portugal to Switzerland, drove off the Nation Road No. 79 at the exit of a viaduct in the municipality of Charolles (Saône-et-Loire department).

This accident cost the lives of 4 people, all passengers on the bus. It also resulted in the hospitalisation of 28 people (3 in critical condition and 25 in critical but stable condition).

The direct cause of this loss of control is most likely an excessive driving speed with regard to the state of the roadway, with a bus whose rear tires were overinflated, thus with reduced adherence, and that was pulling a trailer with faulty brakes.

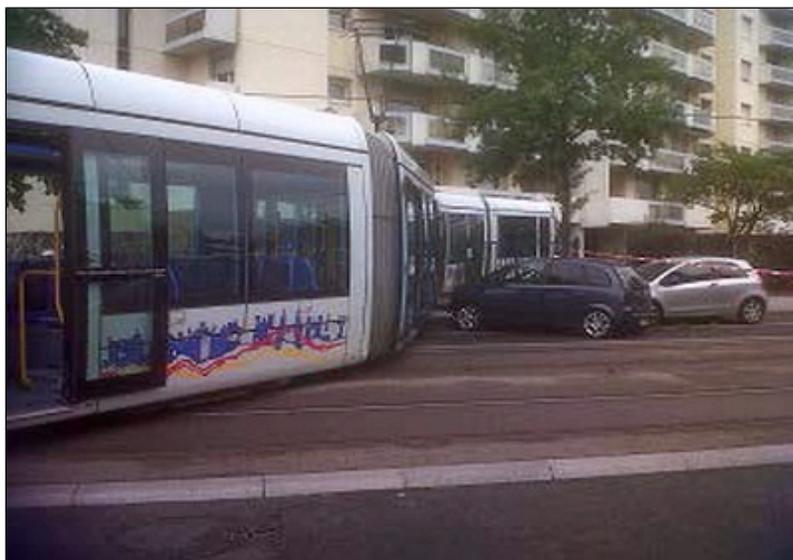
Derailment of a train on the T2 tramway line in Lyon (69) following a collision with a light vehicle on 23 August 2015

At 15:51 on Sunday, 23 August 2015, in the 8th arrondissement of Lyon, a train on the T2 tramway line driving on Jean XXIII boulevard toward its terminal “Saint-Priest - Bel-Air” was struck in the front by a Citroën Berlingo vehicle coming from rue Bataille and entering the platform.

Due to the impact, the three bogies of the train were derailed, and it crossed the adjacent roadway, hit two parked cars in the process, one of which hit a third car by ricochet. It then crossed the fence of a co-property and stopped a few metres from the entrance to the building. It traveled a total of 55 metres following the collision.

The direct cause of the accident was the failure of the vehicle driver to respect his traffic light which had been red for more than 30 seconds.

- the sensitivity of this type of tramway in the event of impacts with roadway vehicles;
- the significant speed of the tramway and the failure of the conductor to brake before the impact.

The analysis of this accident led BEA-TT to issue three recommendations and an invitation on these two subjects.

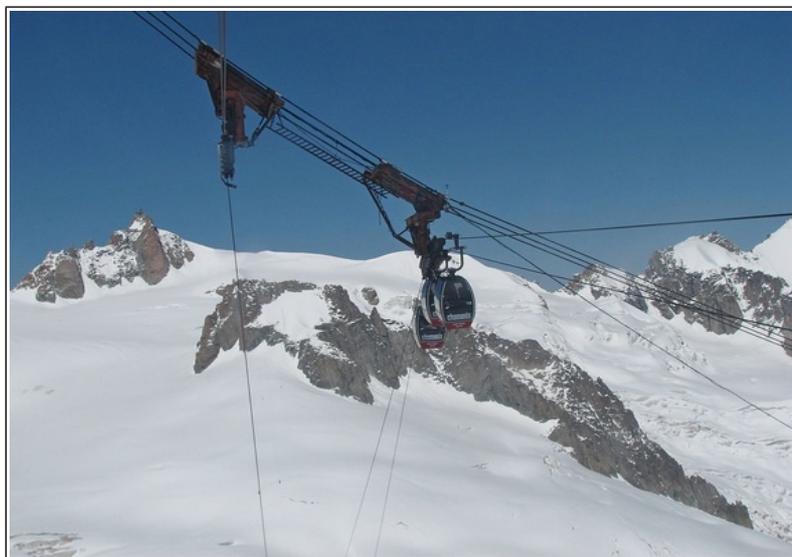
Immobilisation and delayed evacuation of the cable car “Panoramic Mont-Blanc” on 8 September 2016 in Chamonix (74)

The event concerns the Panoramic Mont-Blanc cable car located in the Chamonix commune on the Mont-Blanc massif.

At 15:20, on Thursday, 8 September 2016, following an unexpected stoppage of the device, oscillations of the line occurred and led to a tangling of the traction cable with the carrying cable on three parts of the line.

During the night, the motor was repaired. A new attempt to untangle the cables was carried out at 07:15, with success. It however caused a new incident: the derailing of an empty cabin from the carrying cable. The repatriation of the last passengers was carried out at a low speed and was completed by 08:50. They were stuck on the line since 17:30.

The latent defaults and a weak resistance of the installation and its operation led to a progressive degradation of the situation, which the operator didn't know how to manage without using public rescue services.

- the sensitivity of the device to oscillations of the traction cable which led it to cross the carrying cable in several places and thus led to immobilisation;
- the breaking, during an attempt to uncross the cables, of a badly crimped hose on a motor that had just been replaced and whose ability to uncross the cables had not been verified;
- the omission of devices reducing certain risks of immobilisation, due to an incomplete safety study;
- the overestimation, before the event, of passengers' ability to withstand hostile environments, for a long duration, and the underestimation of the assistance they would need;
- the lack of operational rigor to ensure a high level of safety of the installation.

BEA-TT issued five recommendations and an invitation in the following areas:
