Bureau d'Enquêtes sur les Accidents
de Transport Terrestre

ANNUAL REPORT 2019

2019

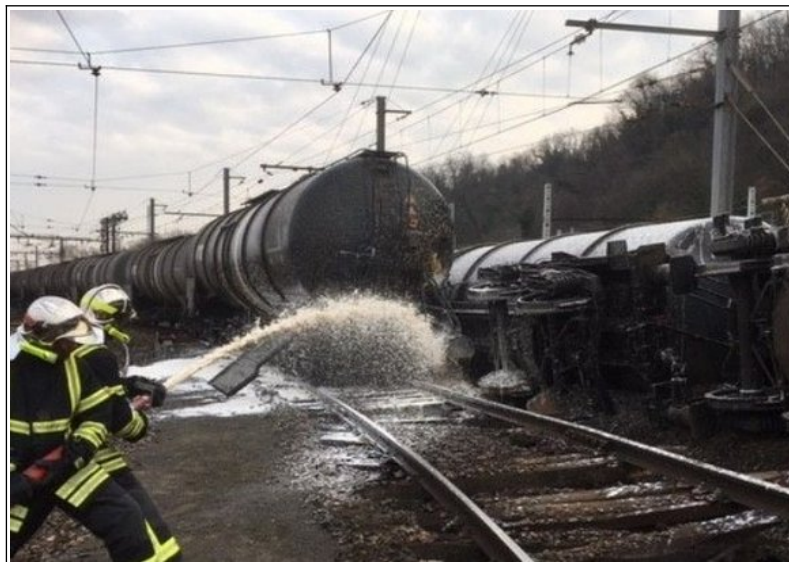
Derailment and load loss for a freight train carrying ethanol which occurred on 13 March 2017 in the Sibelin marshalling yard in the town of Solaize (69)

Monday 13 March 2017 at 4:05 am: a hazardous goods train composed of 22 tank cars loaded with bioethanol; four cars derailed upon arrival on the north-south relay section of the Sibelin yard.

Two tanks tipped over. Another, which hit the overturned tanks, was pierced in two places. Its highly flammable contents began to spill on the ground.

The cause of the accident was the double break of a rail section with the passage of this heavy train. The first failure was fatigue of the rail; its cracking had been quite advanced. The second fracture occurred as a result of the car's guiding forces in the tight curve. These were exerted on a rail weakened by the first fracture, by development of cracking, and by weakened support of fasteners and sleepers in this area being in poor condition. The area isolated by the two fractures rotated sideways under the load, causing the axles passing over it to slip out of the way.

- the advanced state of rail cracking, and lack of a crack inspection operation during maintenance;
- insufficient rail maintenance;
- the generally poor condition of the track which had not been corrected due to maintenance work being postponed.

BEA-TT issued two recommendations and an invitation covering the following areas:

- strengthening rules for monitoring the state of rails cracking on service tracks used by hazardous goods trains;
- improving track maintenance rules for better rail fastening efficacy in areas with tight radius curves;
- compliance with regulatory requirements relating to movement of hazardous goods at the Sibelin site.

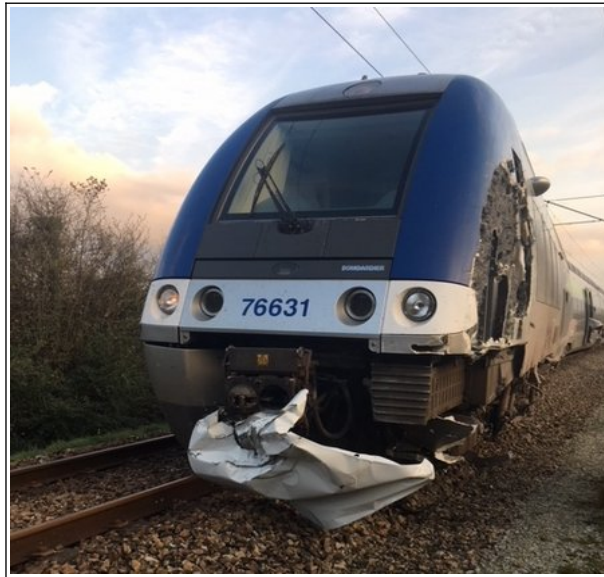
**Collision between a TER [regional train] and an automobile
which occurred on 2 November 2017
on level crossing 8 at Bonneville-sur-Touques (14)**

On Thursday 2 November 2017 at 13:52, the TER (Regional Express Train) no. 852429, coming from Lisieux and heading for Trouville-Deauville, collided with a car on level crossing no. 8 in the town of Bonneville-sur-Touques. This level crossing is an unguarded type with a Saint-Andre cross “STOP” sign.

During the impact, the TER, travelling at a speed of 135 km/h, derailed but did not overturn.

The direct cause of the accident is that the driver of the road vehicle did not perceive the train's arrival before crossing the level crossing.

The underlying cause is that the road vehicle driver entered a dead-end lane, possibly not knowing where he was. Then, just after crossing level crossing 8, the driver noticed the lack of road surface. He probably realised his confusion and started to reverse. He made a U-turn. He entered the level crossing again when the TER arrived on his right.

- level crossing 8 safety diagnosis failed to identify risk factors related to the environment, including signalling access to a dead-end lane, and stopping of the road surface just after the level crossing;
- access to the marshes should only be possible for those who are authorised;
- when crossing the railway, the driver's attention was not captured by a physical light and sound device. Such a device would have been triggered by switching on lights and ringing at least 20 seconds before arrival of the TER at the level crossing, and therefore well before the sound alert of the TER's whistle, which only occurred eight seconds before the TER arrived.

BEA-TT makes two recommendations, one related to the installation near the level crossing of a device preventing access to the level crossing to anyone who is not entitled to do so. The other is related in a general way to automating the level crossing at the Saint-Andre crossing on lines which are travelling at 140 km/h.

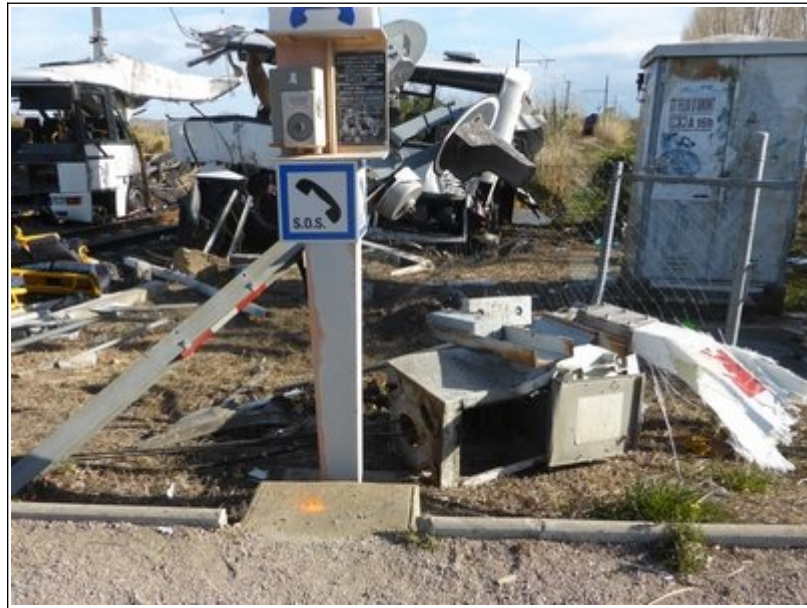
Collision between a passenger train and a coach on 14 December 2017 in Millas (66)

On Thursday 14 December 2017 at about 4:07 pm, the passenger train connecting Villefranche Vernet-les-Bains to Perpignan collided with a school coach on level crossing no. 25, located on departmental road no. 612 in Millas in the Pyrénées-Orientales.

This violent collision resulted in the death of six teenagers and serious injuries to 18 more people on the bus, and minor injuries to a few passengers on the train. This caused extensive damage to the school bus as well as to railway equipment and infrastructure.

1. there was no malfunction in the rail traffic, nor in the triggering of the level crossing 25 equipment;
2. the direct cause of this accident is that the coach did not stop at the level crossing despite the flashing red lights and barrier;
3. the most likely scenario for this accident is that the coach driver did not perceive the closed state of the level crossing despite the signs there.

BEA-TT made recommendations in view of these items relating to:

- the level crossings' position signalling are qualified as road equipment;
- the study to adapt intersections on either side of the level crossing 25 for turning of heavy vehicles;
- changes in the methods of performing safety diagnostics;
- The feasibility of installing surveillance cameras on the level crossing and frontal cameras on trains.
- The possibility to have a directional audible continuous alarm from the time that the barriers are lowered until they are lifted again;
- the feasibility of postponing a level crossing closure alert inside vehicles, coupled with the GPS system and on-board mapping.

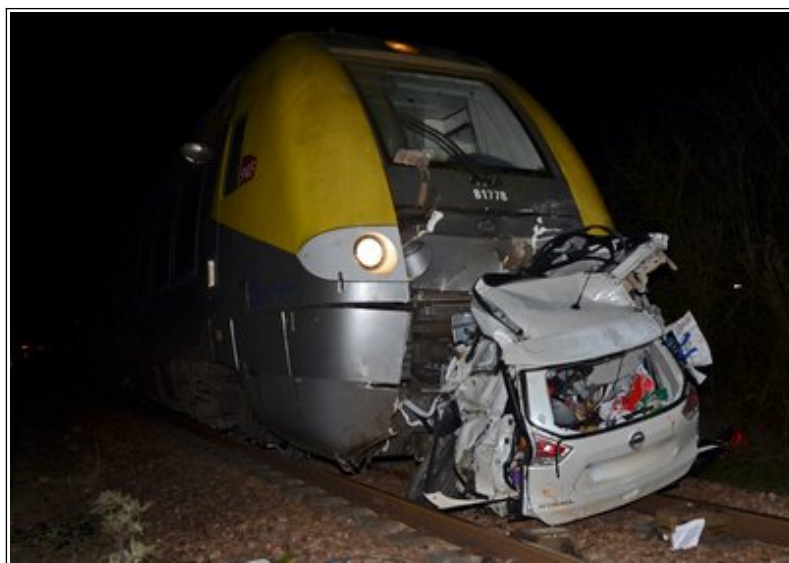
Collision between a TER [regional train] and a light vehicle which occurred on 14 January 2018 at level crossing 19 at Auxerre (89)

On Sunday 14 January 2018 at about 5:34 pm, crossing the hamlet of Jonches, which is on Auxerre's municipal territory on the Yonne, a light vehicle travelling on the RN 77 with two people on board was stopped between the barriers at level crossing no. 19 at the railway line from Auxerre to Laroche-Migennes, was struck by a TER from the Auxerre Saint-Gervais station.

Both occupants of the light vehicle were killed in this collision.

The direct cause of the accident was the sudden restart of the light vehicle, moving forward when the train arrived. The vehicle had been stopped before between the railway track and the half-barrier without encroaching on the area where the train passed by.

Analysis of this accident led BEA-TT to issue an invitation and recommendation related to:

- communication activities to remind people of the dangers of using the telephone while driving;
- equipping vehicles with an event data recorder that records some operating parameters in the moments before and after a collision; these should be used to improve safety.

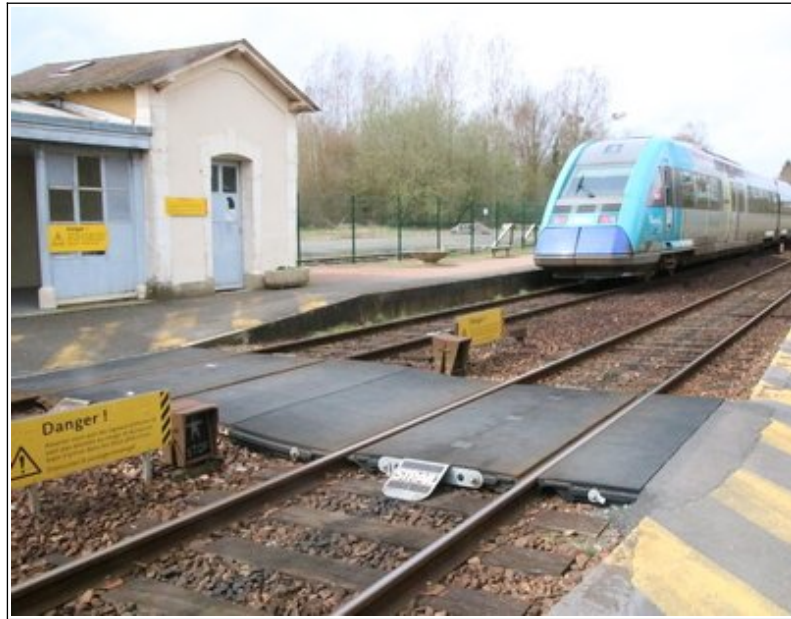
**A pedestrian hit by a train on a level crossing
on 22 February 2018
at Écommoy (72)**

On Thursday 22 February 2018 at 8:06 pm, an empty passenger train on its way to Alençon via Le Mans arrived at high speed at Écommoy station. It crossed a TER which was leaving the station after having stopped there.

Three people crossed the tracks behind the TER on a level crossing. One of them was fatally struck by the empty train.

Investigators identified a lack of attention on the part of the victim as the cause of the accident. The latter should have complied with the signs on the one hand, and checked for the absence of a crossing train on the other. The victim may have felt protected by two other people who crossed in front of her with the same lack of attention.

- the unfavourable configuration of trains stopping at the station involving the level crossing and hindering the observation of pictograms and crossing trains by pedestrians;
- the signs and displays were counselling caution were insufficiently perceptible;
- improving the effectiveness of public awareness of railway risks at stations;
- the growing discrepancy for pedestrians between the attention required related to railway hazards and that which they pay related to hazards in public spaces;
- the absence of any effective barrier to avoid collisions in the event of a pedestrian's lack of attention when taking the level passage.

BEA-TT issued five recommendations and an invitation related to deployment of track crossing signalling recorders, the choice of where trains stop at stations, improving safety signage on platforms, strengthening communications to the public about railway hazards, and studying safety barriers to physically block crossings.

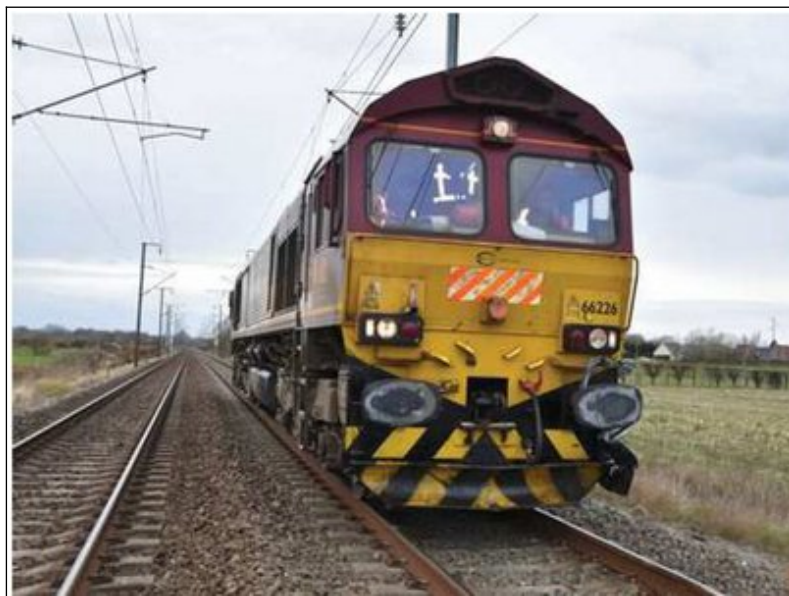
**Collision between a locomotive and a light vehicle
which occurred on 3 April 2018
at level crossing 82 in Coulogne (62)**

On Tuesday 3 April 2018, at around 3:55 pm, a locomotive connecting Calais to Lille collided with a Citroen type C3 automobile at level crossing no. 82, which is located on departmental road no. 247E1 in Coulogne.

This violent collision caused the death of the car's two occupants when the locomotive, travelling at 75 km/h, struck the car on its right side. The locomotive driver was slightly injured. The shock destroyed the car. The railway equipment was undamaged.

The direct cause of this accident was failure to observe flashing red lights, and bypassing the lowered half-gate at the time that the locomotive arrived.

However, feedback from similar accident investigations leads the BEA-TT to stress the need for prior consultation between road and railway managers in the case of work near a level crossing, and to remind them of the recommendations for such a circumstance explained in the information note from the department for transport, roads and their improvements (SETRA), entitled "Road works near level crossings".

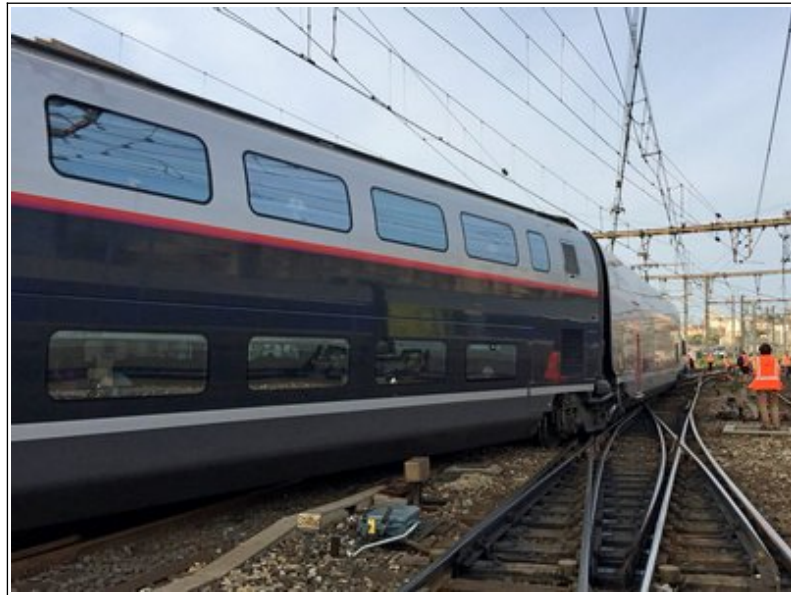
**Derailment of a TGV
which occurred on 24 August 2018
at the station of Marseilles Saint-Charles (13)**

Friday 24 August 2018, just before 6:00 pm, the TGV 6145 coming from Paris arrived at the Marseilles Saint-Charles station, its terminus. The TGV was made up of two elementary trainsets coupled in a multiple unit. As the train was travelling 28 km/h and the front already reached the platform, the rear train derailed with the last seven cars and the last power unit.

The TGV travelled 155 metres before stopping, causing extensive damage to the switches and crossings caused by the derailed wheels. The derailed cars and power unit suffered multiple damage to the lower parts. No passengers were injured. Evacuation procedures proceeded smoothly.

The root cause of the derailment was the break during passage of the train of a rail switch at the station entrance yard.

Investigations showed that this rail, located in the outer curve of the diverted track from the switch, was subject to a great deal of stress. Various signs that the switch had deteriorated, such as the appearance of play in the supports of the broken rail, and abnormal wear of an opposite guard rail, show the intensity of the stresses. These indicate insufficient maintenance of the rail resulted in these occurrences.

Three factors combined to cause the rail to break:

- the intensity of the guiding forces exerted by the wheels on the rail in the tight curve;
- the lateral mobility of the rail resulting from play increasing in the hitch system over time;
- the rail's strength weakened due to the start of a crack that originated in rail damage resulting from an old tamping operation.

Various signs of deterioration were seen on the switch. These included guard rail wear, creep of the rail support saddles, loosening of the chair screw, the notched state of the sleepers and rail damage, which had not been identified during maintenance operations. The infrastructure manager's instructions did not explicitly state that these items were critical.

BEA-TT issued a single recommendation relating to reinforcing the fastening system or, failing that, reinforcing maintenance of external deflection rails for tight radius curves.

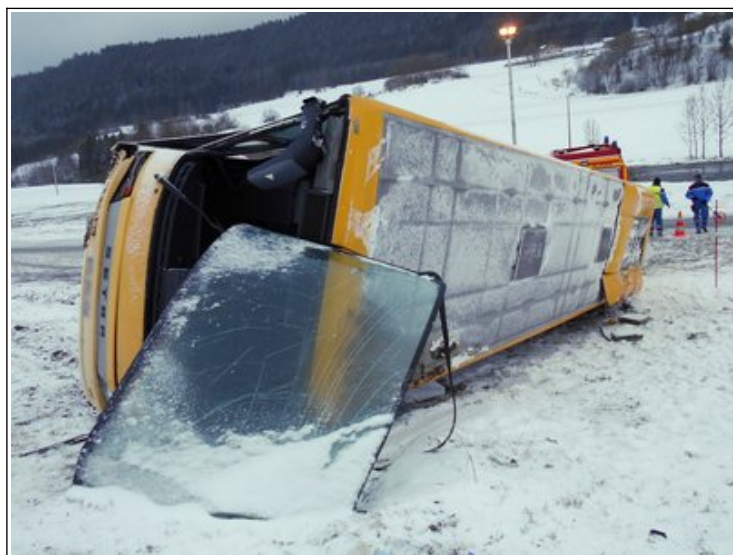
A coach left the road on 10 February 2016 on the RD 437 in Montflovain (25)

On 10 February 2016 at about 7:30 am, a school bus travelling on the departmental road (RD) no. 437 in the direction of Pontarlier with 32 passengers, skidded on the snowy and icy road. It collided on the right of the road and ended in a field, tumbling to its left side.

The accident toll was two young children killed. They were thrown from the bus and crushed under it. Four were injured: three children plus the bus driver. The other 26 passengers were unharmed.

The root cause of this accident was loss of control of the coach.

In view of these items, without issuing a new recommendation, BEA-TT invites the Director General for Infrastructure, Transport and the Sea and the Road Safety Delegation to continue their activities in line with recommendations made to them. These were sent by the BEA-TT in its technical investigatory report on the departure of a school bus on 3 February 2014 on the RD 160 in Einville-au-Jard (54). BEA-TT asks, if necessary, to use regulatory means to ensure promotion to all coaches providing school transport, regular interurban lines or occasional medium- or long-distance service, of pre-recorded messages, audio or video, informing passengers of the importance and obligation to wear seat belts.

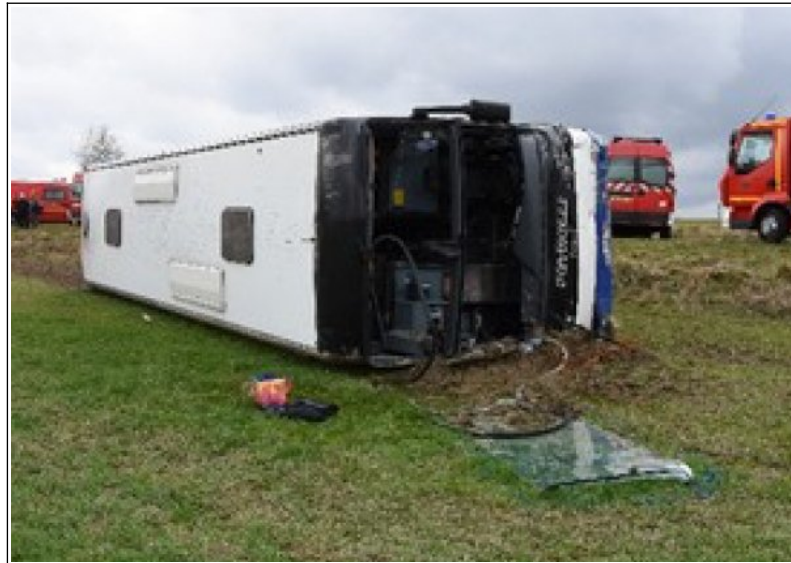
**Accident between a school bus and a light vehicle
which occurred on 25 January 2018
in Manciet (32)**

On Thursday 25 January 2018 at about 12:30 pm, a coach transporting students of the third grade, accompanied by teachers, travelled on the 524 towards the town of Eauze. It arrived at the junction with municipal road no. 6, and collided on the front left with a light vehicle which had started to cross the national road just in front of it.

Surprised by this manoeuvre, the coach could not avoid the car, and, with this shock, propelled the light vehicle into the left ditch and swerved to the right with a trajectory which slightly deviated from the road, heading towards the bordering field. As the difference in level between the side of the road and the field alongside increased as the vehicle moved forward, the right wheels gradually lowered in relation to the left, which remained at road height. The coach leaned over, rolled onto its right side, struck the wet ground, and slid for about 20 metres before coming to a stop.

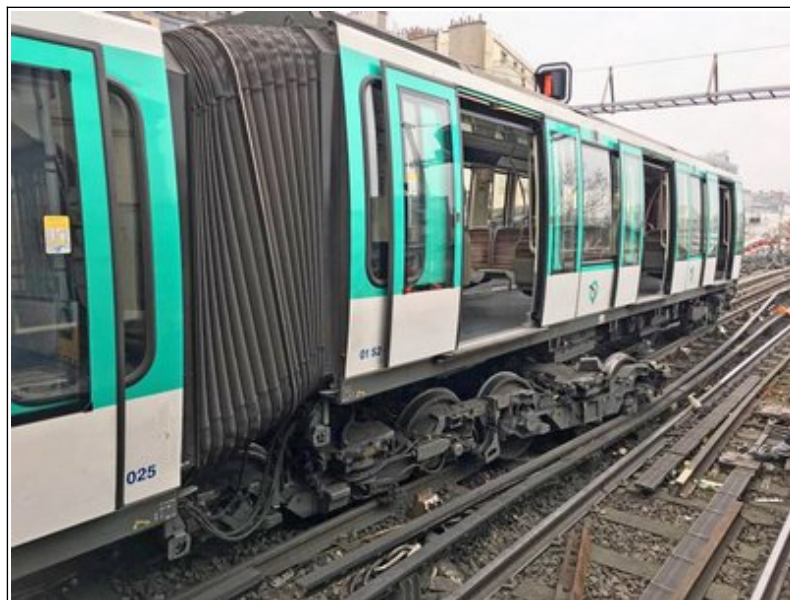
Derailment of a metro train running on line 2, Paris metro that occurred on 2 december 2016 at Barbes-Rochechouart in Paris

On Friday 2 December 2016 at 12:01 pm at the Barbes-Rochechouart station on line 2 of the Paris metro, the fourth and fifth cars of a train travelling in the direction of the Porte Dauphine derailed when entering the station. Damage to infrastructure and rolling stock was significant. No passengers were injured in the accident, nor during evacuation of the train.

The direct cause of the derailment was the inverter box, which fell from the fourth car, located under the chassis, during the La Chapelle-Barbes-Rochechouart passage. This car's bogie axles moved to the boot, which then led to the derailment.

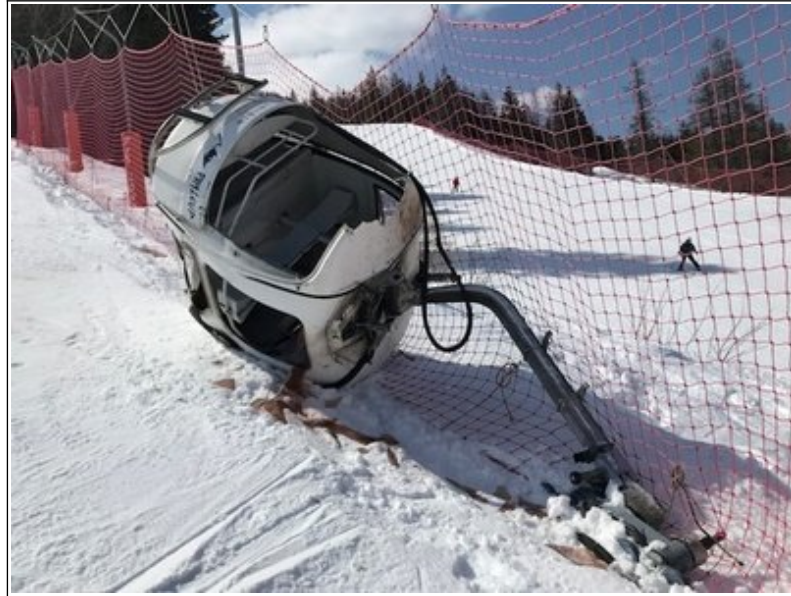
Fall of a cabin on the Costebelle gondola lift on 25 March 2018 in Pra Loup (04)

The incident was with the Costebelle gondola lift located in the Pra Loup ski resort, in Uvernet-Fours in the Alps of the Haute-Provence.

On Sunday 25 March 2018 at 1:33 pm, cabin 7 of the Costebelle gondola lift fell a dozen metres shortly after leaving the lower station. It hurtled slowly down the slope before stopping at the nets below. The cabin was empty, and there were no casualties. The system came to a standstill after the emergency stop push-button was actuated by the driver, who was informed of the fall of the cabin by radio.
