ANNUAL REPORT 2022

A word from the director

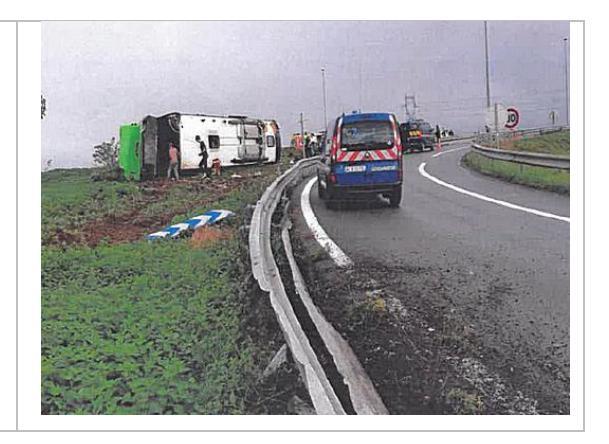
Flixbus coach crashed on November 3, 2019 on the A1 motorway in Estrées-Deniécourt (80)

On Sunday, November 3, 2019, a FlixBus coach left the road on exit ramp +13 of the A1 motorway in the direction of Paris towards Lille in the commune of Estrées-Deniécourt.

During this departure from the road, the coach overturned and came to rest on its right side in the grassy embankment bordering the exit ramp.

The coach's bodywork was severely damaged. The damage to the road infrastructure was moderate; a restraint system (a crash barrier with a motorcycle screen) was destroyed over a few meters.

The direct and immediate cause of the accident was the excessive speed of the coach entering the very tight bend of the exit ramp.

The BEA-TT makes recommendations and invitations on this subject, as well as on the organization of transport companies and their safety management, and another, local one, relating to the reinforcement of the signage of exit ramp no. 13.

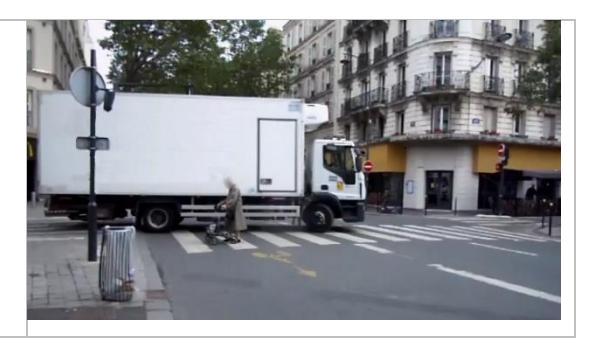
Pedestrian hit by heavy goods vehicle on May 4, 2021 in Clichy (92)

On Tuesday, May 4, 2021, in Clichy (Hauts-de-Seine), at around 9:20 a.m., a heavy goods vehicle (HGV) turning right from Rue de Neuilly onto Boulevard Jean-Jaurès (RD 911) struck a pedestrian crossing the boulevard. The 90-year-old pedestrian was thrown to the ground. The truck driver, not noticing the collision, continued his movement, and the right front wheel of the HGV rolled over the victim, killing her instantly.

The direct cause of the accident was the lack of mutual awareness, by the driver of the heavy goods vehicle and the pedestrian, of the presence of the other person involved.

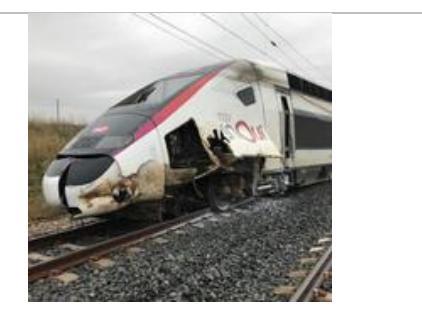
Derailment of a TGV on the LGV Est Européenne on March 5, 2020 in Ingenheim (67)

On Thursday, March 5, 2020, at 7:32 a.m., TGV 2350 from Colmar to Paris was traveling along the East European high-speed line. Traveling through an area of the line that was being cut near the town of Duntzenheim, it hit a mound of earth covering the track at 284 km/h.

The TGV derailed under the impact. The front power car swerved and crossed the platform. It came to a standstill on the opposite track. The first three trailers also derailed, remaining astride the initial track. The articulated elements of the train remained attached and continued their course without deviating from the railway platform until they came to a complete stop, 1,635 meters after the initial impact, in the municipality of Ingenheim.

The immediate cause of the TGV derailment was the impact of the mound of material on the track resulting from the sliding of the adjacent embankment.

The cause of the slope slippage is its instability due to the low resistance of a particular geological formation constituting it: Domérien clays. The resistance of this formation had been overestimated during the stability justification at the time of design.

The BEA-TT issues four recommendations and three invitations to prevent this type of accident, relating to the restoration of safety of the embankment, the rules for the construction and monitoring of such embankments, and the strengthening of the robustness of the radio alert whose operation was affected during the accident.

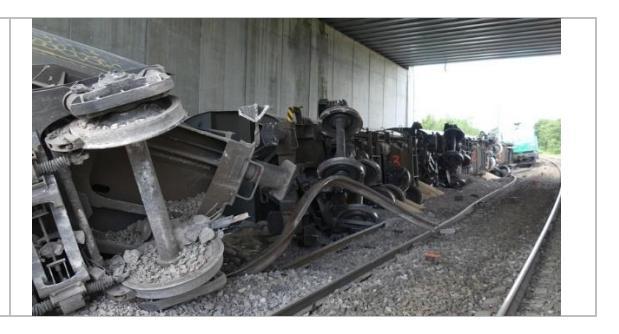
Derailment of a grain transport train on August 26, 2021 in Saint-Hilaire-au-Temple (51)

On Thursday, August 26, 2021, at 10:04 p.m., freight train No. 71 646 of the SNCF Freight Railway Company, traveling from Châlons-en-Champagne to Tergnier, derailed at Saint-Hilaire-au-Temple (Marne). The train was carrying 20 grain wagons. It derailed shortly before a rail bridge allowing passage under the East European high-speed rail line. The locomotive and the last 7 wagons of the train remained on the rails, while 13 wagons lay over and became entangled. Two wagons struck the left support wall of the structure, causing the locomotive to stop abruptly and the following wagons to "accordion" in shape. The train driver was injured and shocked. 150 m of track was destroyed. Traffic between Châlons-en-Champagne and Reims has been suspended for 35 days.

The cause of the derailment was a multiple rail break under the passage of the train, in the low line of the curve. The rail was affected by a longitudinal vertical cracking defect of the head, codified 213, which had existed for several years. The rail in question was reused, low profile, and of old manufacture (1955).

- > the operating conditions of this section of track, in terms of speed and load, have intensified, increasing the dynamic stresses on the rails;
- > the rail monitoring policy did not allow the longitudinal vertical cracking defect of the rail head to be detected in time and corrective action to be taken;
- > The train stopped suddenly when two of the train's carriages crashed into a ledge of the railway bridge with the East European high-speed line.

- > Improving the reliability of rail heritage data with regard to the actual condition of the reused rails and reviewing the requirements with a view to guaranteeing the gradual eradication of the oldest rails or their good working order.
- > Adapting the methods for monitoring the actual condition of the rails in order to address the risks linked to the age of old rails.
- > Improving the detection of longitudinal vertical cracking defects by heavy rail inspection equipment using new technical means.
- > Verification that the agents in charge of rail tours are well trained for this mission and have suitable practical support to assist them.
- The revision of UIC leaflet 777-2 to improve the treatment of the risk for rail traffic hitting a clear obstacle constituted by a structure.

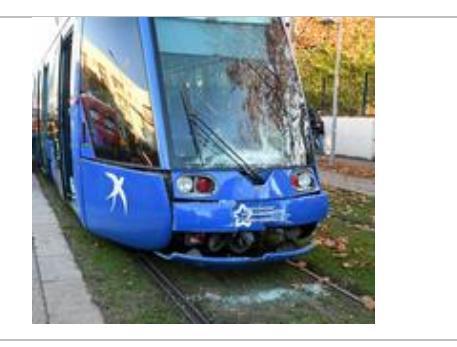
Collision by catching up two tram trains on December 2, 2019 in Montpellier (34)

On December 2, 2019, in the early afternoon, a tram breakdown on line 1 of the Montpellier network caused several trams to pile up in the Château d'Ô area. In this situation, tram number 2012 stopped in line, about a hundred meters before the Hôpital Lapeyronie station. Four minutes later, traveling behind it, the driver of tram number 2028 left the Universités des Sciences et des Lettres station: alongside the CHU Lapeyronie, he saw tram number 2012 in front of him. He braked, applied the magnetic brake pads, then two seconds later engaged emergency braking. The tram slowed down, but not enough. Despite exceeding the speed limit, when the driver applied the emergency brake, the distance in front of him was sufficient for him to be able to stop before the rear of tram number 2012 in a normal situation. However, he hit it at an estimated speed of between 15 and 20 km/h.

The collision left 41 passengers on both trams with minor injuries, an estimated 200 people. Material damage was reported on both trams.

Tram No. 2028's braking performance, when encountered with a skid, was lower than expected, causing the collision. The complexity of the vehicle-track interaction required a systemic analysis to investigate the causes of the skid. Several contributing factors were identified:

- the driving behaviour of the driver of tram no. 2028, placing heavy demands on the rolling stock, in the context of unfavourable operating conditions;
- reduced grip in the presence of a rail that has not been recently cleaned and probably greased;
- > probably faulty sandblasting on part of the motor bogies at the ends of the tramway.

The BEA-TT issues 7 recommendations and 3 invitations, relating to the training and monitoring of tram drivers; to improving the traceability of maintenance actions, whether on the track or on the trains; and to the anti- -skid function for future tram rolling stock

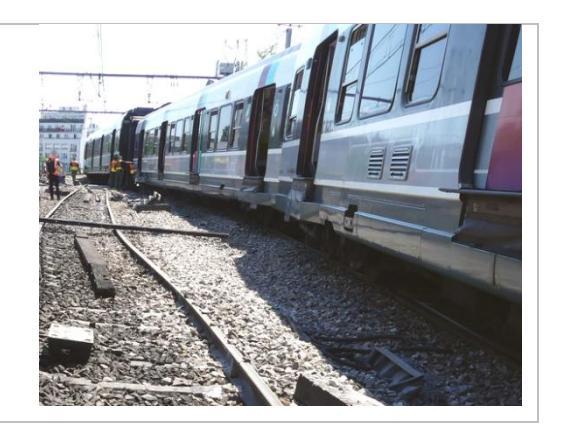
Derailment of an RER B train on June 24, 2020 near Denfert-Rochereau station (75)

On June 24, 2020, shortly before 7 p.m., an MI79 RER B train departed from platform 3 of Denfert-Rochereau station.

Less than two minutes later, during a track change, the train derailed as it passed the tip of a switch on the right: the first axle of the front bogie of the 6th car derailed by the wheel climbing onto the left switch point of the switch; the second axle derailed before the frog tip of the switch.

The derailment was caused by a defect in the rail-wheel interface at the track device where the wheel lift occurred.

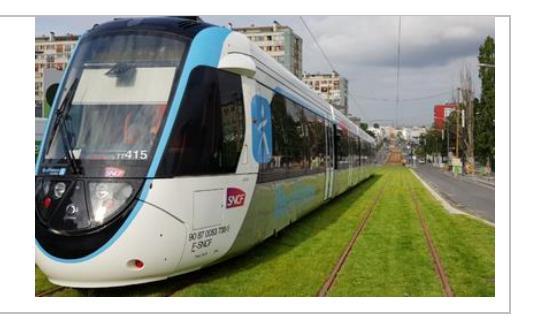
Line T4 tram train derailed on November 8, 2020 in Clichy-sous-Bois (93)

On November 8, 2020, on the Ile-de-France T4 tram line operated by SNCF Voyageurs, a train in commercial traffic traveled along a 7% gradient between Maurice Audin and Clichysous-Bois-Mairie stations. At the top of the gradient, the tram driver reduced speed to stop in front of a tram road sign prohibiting it from crossing an intersection. The train then rolled backwards, in the downhill direction, reaching speeds of 63 km/h. The train was finally stopped by the driver using emergency braking, after 430 meters of drift.

The consequences could have been serious. Fortunately, no one among the forty passengers on board was injured and there was no material damage.

The cause of the drift was the combination of maintaining traction and the driver's inappropriate professional action, namely moving the direction selector to the "zero" position when stopping in front of the tram road signal. This action led to the deactivation of the antidrift safety device. Prescribed for stopping in front of a rail route signal, the action was not appropriate for tram road signals. In addition, during the initial stop at the top of the ramp, the driver left the joystick in the "traction" position. The parking brakes, which could have held the train, were therefore not activated.

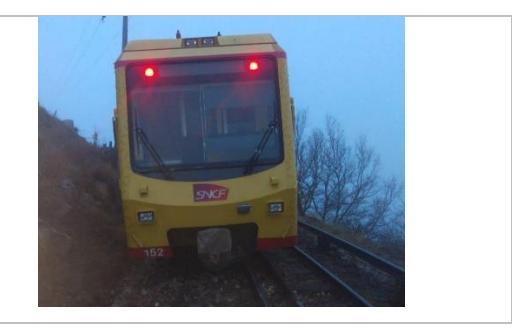
Train derailment on January 25, 2021 in Fontpédrouse (66)

On January 25, 2021, at the end of the day, Regional Express Train No. 23006 was traveling from Latour-de-Carol station toward its terminus station at Villefranche-Vernet-les-Bains on a single, metre-gauge track. This Z150-type railcar, although in commercial service, did not carry passengers. Only the driver and the conductor were on board.

From the Gisclard Bridge, on the descent of the Têt Gorges, an intense fog enveloped the train. It suffered several skids, which the driver managed by applying electric braking and then by using the -sanding and traction control push buttons. The train's speed exceeded the authorized speed limit of 30 km/h and continued to increase. A final skid occurred at high speed. The driver was unable to regain traction by applying the same actions as before and did not use the air brakes. The convoy arrived at the entrance to the La Castagnal tunnel (right-hand curve) at a speed of 56 km/h.

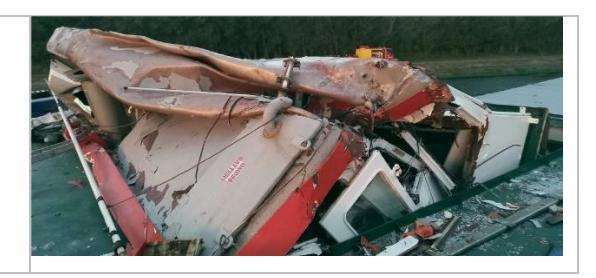
Collision of two bridges by the river-sea vessel ANDRE MICHEL1 on October 2, 2021 on the Rhône diversion canal at Donzère (26)

On Saturday, October 2, 2021, the river-sea vessel² ANDRE-MICHEL 1, flying the Maltese flag, is going up the Rhône, on ballast, from Torre Annunziata in Italy and bound for Saint-Usage (21) where it will load wheat.
