# **ANNUAL REPORT** 2020

#### Land Transport Accident Investigation Bureau

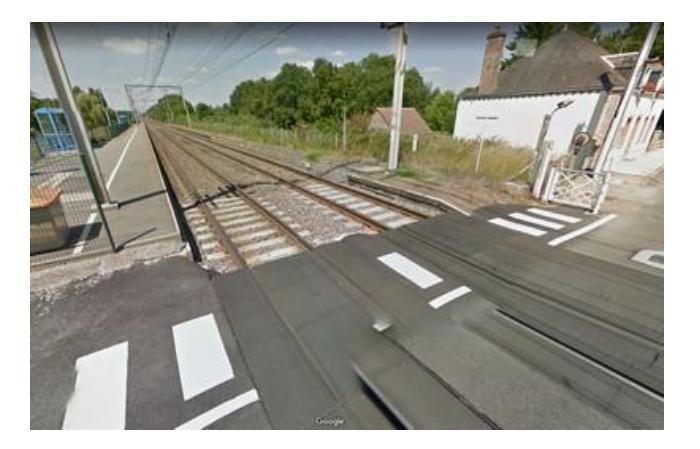
Pedestrian hit by a regional express train on 3 September 2018 in Nouan-le-Fuzelier (41)

On Monday 3 September 2018 at 6.41pm, a 15-year-old teenager was hit by a train as he crossed the tracks on the guarded and closed level crossing at Nouan-le-Fuzelier station. After getting off a TER train serving the station, the teenager had put on a headset and set off to cross the tracks at the back of his train via the level crossing in order to reach the town center. He was hit by a cruiser train travelling at 145 km/h. He died while being taken to hospital.

The route used, which was shorter than the normal exit but signed as forbidden to passengers, deprived him of observing the level crossing signage which was lit and of stopping by the gates which were closed. His attention was taken up by his smartphone and he did not hear the warning calls of the barrier guard and others who got off the same train. He continued to cross.

The BEA-TT made three recommendations to SNCF Réseau concerning:

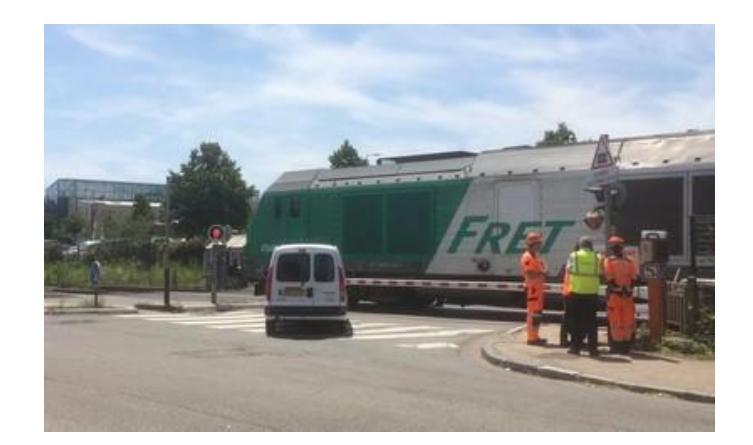
Collision between a regional express train and a light vehicle 7 May 2019 on LC 302 in Saint-Étienne (42)

On Tuesday 7 May 2019, at around 3.10 pm, regional express train no. 889 925 coming from Boën-sur-Lignon (42) and bound for Saint-Étienne Chateaucreux station (42) collided with a light vehicle at level crossing no. 302 in the commune of Saint-Étienne.

During the impact, the TER, which was travelling at a speed of 88 km/h, did not derail or overturn.

The direct cause of the accident was the failure of the light vehicle to stop, despite the flashing red lights and the barrier that required it to do so. This vehicle bypassed the central island upstream of the LC and entered the opposite traffic lane, without encountering any vehicles, since they were stopped in front of the other half barrier.

The BEA-TT has made recommendations on:

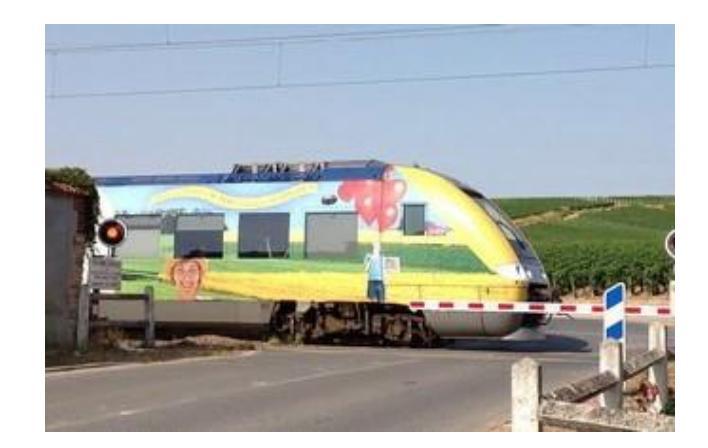
Collision between a regional express train and a light vehicle 15 July 2019 on LC 2 in Avenay-Val-d'Or (51)

On Monday 15 July 2019, at 9.45 am, Regional Express Train (TER) no. 839 945 coming from Épernay (51) and bound for Reims (51), collided with a light vehicle at level crossing no. 2 in the commune of Avenay-Val d'Or (51). This crossing was equipped with automatic light and sound signals with two half barriers.

The four occupants of the light vehicle, the 37-year-old driver and three children aged 10, 3 and 10 months, were killed instantly.

The direct cause of the accident was the failure of the light vehicle to stop at the closed level crossing.

In view of the contextual elements identified and the high level of seriousness generally observed for all users involved in these types of accidents between a train and a road vehicle, the BEA-TT is led to seek preventive orientations in the fields of the visibility of the closed state of a level crossing and in the driving assistance for road vehicles.

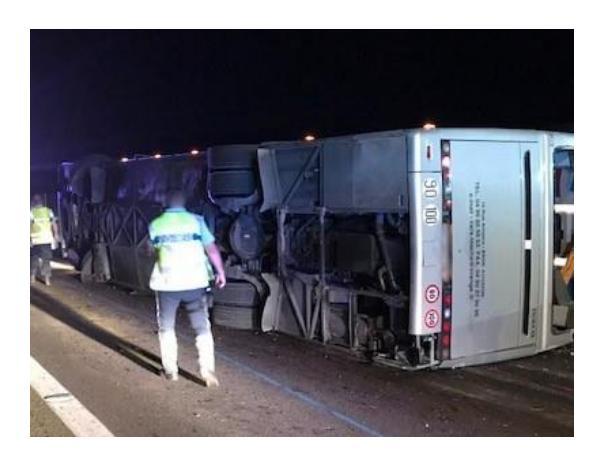
Bus accident on 26 May 2018 on the A7 motorway in Chantemerle-les-Blés (26)

On Saturday 26 May 2018 at around 10.47pm, a coach travelling on the A7 motorway with 31 people on board, including 18 children, swerved sharply to the right, hit the concrete barrier lining the road, overturned on its right-hand side, slid off and came to rest on the hard shoulder.

The accident resulted in the death of the driver and two passengers of the coach, all three of whom were ejected in the accident. Eight passengers were declared in absolute emergency and six in relative emergency. Fourteen passengers were uninjured.

The severity of the accident was most likely due to the driver and several passengers not wearing seatbelts.

The accident caused extensive damage to the coach and moderate damage to the road infrastructure.

The direct and immediate cause of this accident was the sudden loss of control of the coach as a result of the explosion of the right front tire.

The analysis of this tire showed that a previous impact on the tread was most likely the cause of the loss of mechanical properties of the rubber, which, over the course of the kilometers travelled, led to the degradation of the tire structure until it burst.

The BEA-TT made recommendations on:

- checking the internal condition of the tires during any dismantling;
- > the definition of specifications relating to the resistance of tires to external impacts;
- $\succ$  the wearing of seat belts.

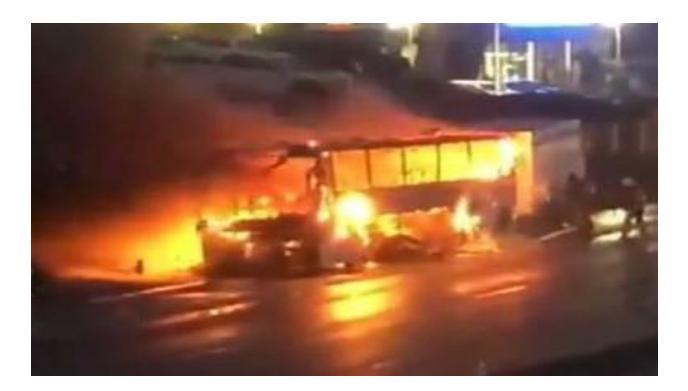
Bus fire on 10 March 2019 on the A6 motorway in Le Coudray-Montceaux (91)

On Sunday 10 March 2019 at around 6.30 am, a fire broke out on board a coach travelling on the A6 motorway towards Paris, near the town of Le Coudray-Montceaux (91). The driver parked his vehicle on an asphalt area bordering the hard shoulder of the motorway. The 50 passengers and the two drivers managed to evacuate the coach.

One of the passengers injured his hand when he tried to break a window before stopping. The fire had no other physical consequences except, for some passengers, the inhalation of toxic gases without lasting consequences.

In material terms, the entire coach was burnt, including the luggage it was carrying in the hold. The trailer was only slightly damaged by the flames.

The direct cause of the fire was an overheating of the fixing terminal of the electrical cable supplying the control panel of the air conditioning unit located on the roof of the coach. The high temperature rise is believed to be due to abnormal resistance or insufficient contact area of the fixing terminal caused by a loose or insufficiently tightened nut.

The BEA-TT issued one recommendation and two invitations on :

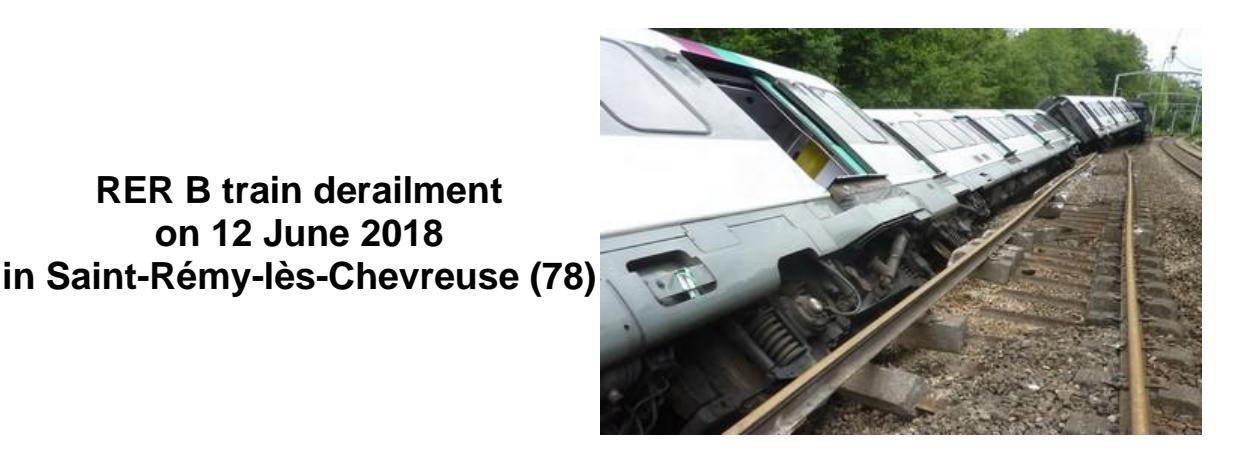
**RER B train derailment** on 12 June 2018

On Tuesday 12 June 2018 at 5 a.m., on line B of the Ile-de-France RER, between the stations of Saint-Rémy-lès-Chevreuse and Courcelle-sur-Yvette, on the boundary between Essonne and Yvelines, a train travelling to Paris derailed and partially went down.

The front engine remains on the track, while the 2<sup>e</sup>, 3<sup>e</sup> and 4<sup>e</sup> cars are lying on their left side and have tipped over into the ditch. The trailing train, which remained clinging to the derailed cars, also remains on the track.

The direct cause of the accident was the hollowing out of the embankment supporting the track over a length of about fifteen meters and to a depth of about four meters.

This hollowing out was caused by scouring due to overflow over the line embankment, following heavy rainfall in the Paris region that night.

The BEA-TT issued two recommendations to RATP in the following areas:

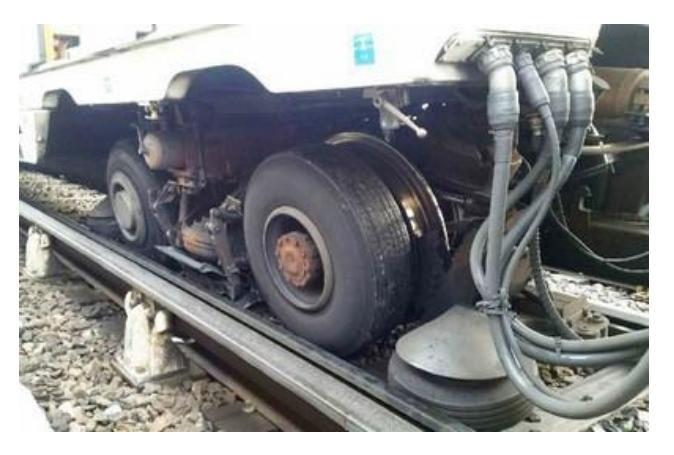
## Derailment of a metro train on 21 December 2018 in Marseille (13)

On Friday 21 December 2018, at 8.25am, a train on line 2 of the Marseille metro derailed from a bogie, just after it left the Sainte-Marguerite-Dromel terminus station in the direction of Bougainville.

The train was carrying around 100 passengers who were evacuated in good conditions. Fourteen people injured as a result of the shocks were taken care of by the marine fire brigade. After the train was removed and the track was repaired and checked, the line resumed operation at around 4pm the next day.

The cause of the derailment of the train was the loss of a part of a motor bogie in a switch core. This was a negative friction wheel. It obstructed the passage of the wheels and caused the wheels of the following bogie to rise and derail. The derailed bogie remained close to its track but pushed the power supply side bar against the tyre tread of the adjacent track. This triggered the disconnection of the power supply and thus the automatic stop of the train.

Two parts of the switch can be the cause of the impact: a protruding angle of the shoulder of the guard rails, or a sharp edge of the so-called direct hare's foot.

> the failure to assess the risk of interaction between the track and the bogie part at the design stage, and consequently the absence of a maintenance prescription for the switches to prevent this risk from developing;

> the failure to identify the recurrence of previous breakages of this part as a precursor to a safety hazard.

The BEA-TT issued 3 recommendations and 2 invitations:

> the treatment of the risk of loss o f a rolling stock component in the preliminary hazard analysis prior to the commissioning of equipment;

> identification of potentially hazardous components and their treatment;

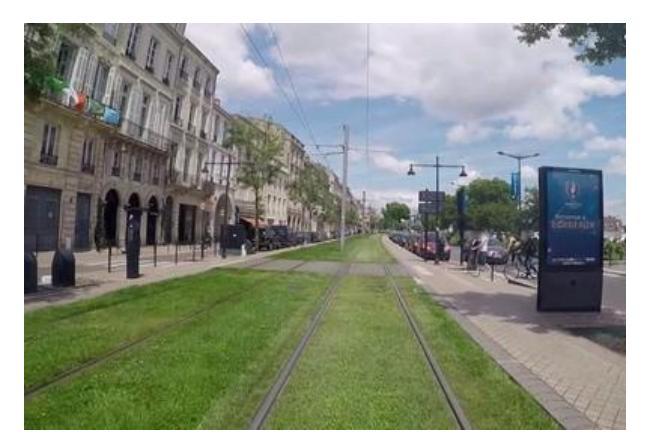
## Pedestrian struck by a tram 22 February 2019 quai des Chartrons in Bordeaux (33)

On Friday 22 February 2019 at 9.22pm, on the quays of the Garonne in Bordeaux, a tramway train travelling on line B between the "Chartrons" and "Cours du Médoc" stations struck a woman who was using a pedestrian crossing of the tramway platform.

The impact occurred at t h e front right of the train. The pedestrian hit was thrown forward 12 meters, slightly to the side of the platform. The train was stopped by the driver immediately after the impact.

The cause of this accident was the late perception of the tram train by the pedestrian. The pedestrian ran into the lane in front of the tram, while the speed of the tram did not allow the driver to stop in time.

The BEA-TT issued two recommendations and two invitations concerning the treatment of visibility masks, the rules of conduct for trams and the layout of pedestrian crossings of tram platforms.

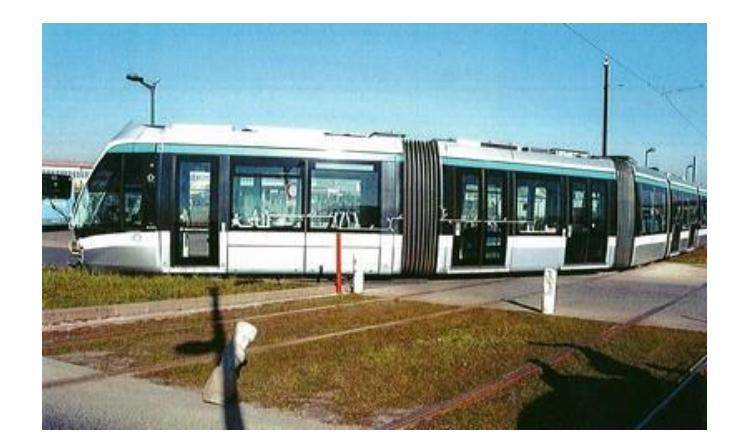
Collision between a T7 tram and a bus 27 February 2019 in Paray-Vieille-Poste (91)

On Wednesday 27 February 2019 at around 1.20 pm, in the commune of Paray-Vieille-Poste (91), a train of the T7 tramway line, travelling towards the "Villejuif - Louis Aragon" terminus, collided with a bus travelling on rue Marcel Albert in the north direction. The coach was operating the regular 91.10 line of the IIe-de-France bus network.

Under the impact, the train derailed from two of its three bogies. As a result of this accident, one person was hospitalized for five days and six passengers in the coach were slightly injured; four passengers in the tram were slightly injured.

The direct cause of the accident was that the bus crossed the intersection while the traffic lights required it to stop.

The failure of the coach driver to see the road lights, the tram driver's attention to an oncoming vehicle and the lack of emergency braking by the tram contributed to the collision.

The BEA-TT issued four recommendations and three invitations concerning:

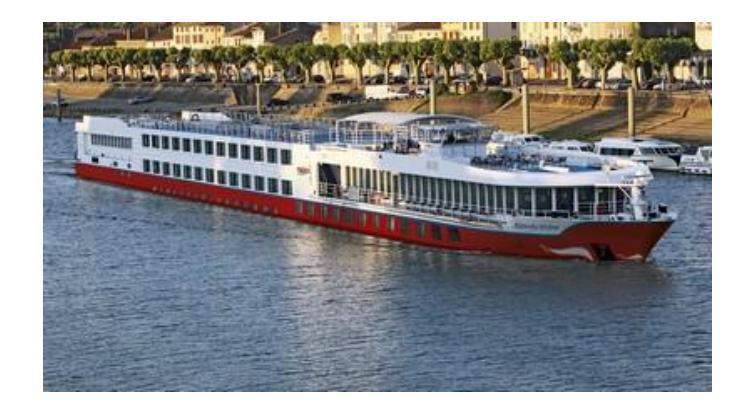
Striking of a motorway bridge by the passenger boat BIJOU DU RHÔNE 6 April 2018 in Givors (69)

The passenger boat "Bijou du Rhône" operates cruises on the Saône and Rhône rivers between Chalon-sur-Saône and Arles. It left Lyon at the start of the cruise and is now travelling down the Rhône, about to pass under the A47 motorway bridge near the town of Givors on Friday 6 April 2018 at 11.40pm.

Three quarters of the way through the channel, the vessel struck a bridge pier in the middle of the river on its starboard beam. A leak occurred in a crew cabin. The captain decided to tie up as quickly as possible in order to secure the 127 passengers and crew.

The investigations carried out established that the direct cause of the accident was the incorrect approach to the bridge by the boat, which was too far to the right of the channel.

The BEA-TT has formulated preventive recommendations in the field of navigational aid signaling on the approach to the Givors bridge.
